Lead Based Paint Inspection Report

**Building 452 Hangar
Columbus AFB
Columbus, Mississippi**

Project AEC 096.24

October 30, 2024

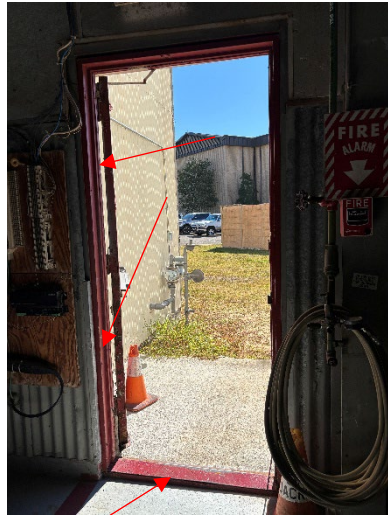
**Door/ Door Trim/ Door Threshold
Hangar (Side A)**

AEC recommends prior to any renovation that a MDEQ licensed Lead Abatement Firm and/or Lead Renovator Firm is utilized for removal and/or encapsulation of all lead components during renovation. AEC further recommends that the HUD and MDEQ guidelines be followed.

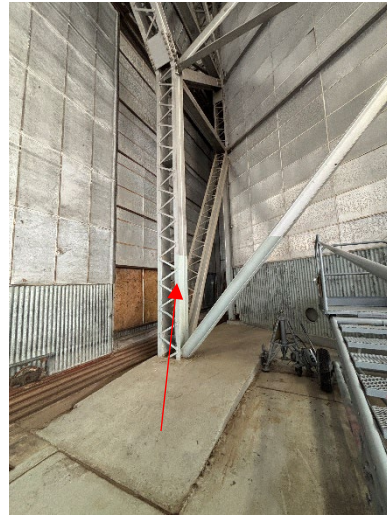
**Beam 3
Hangar (Side D)**

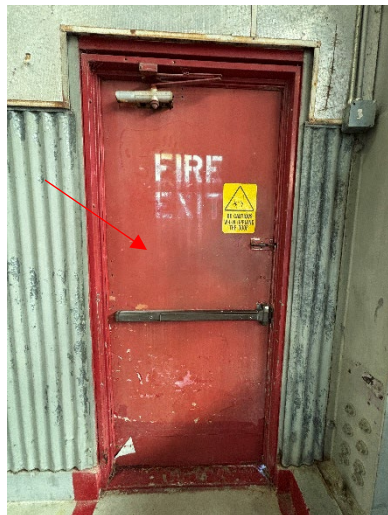
**Door
Hangar (Side D)**

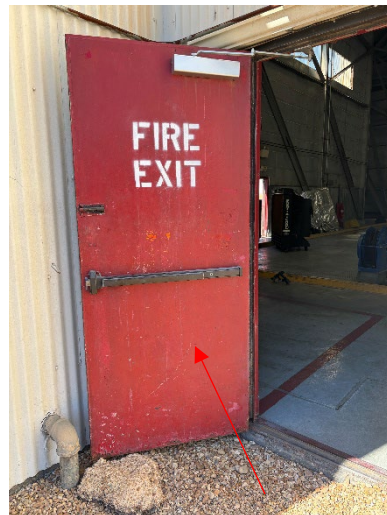
**Door 2
Hangar (Side A)**

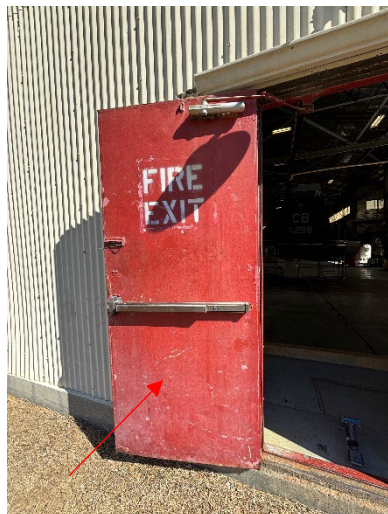
**Door
Hangar (Side B)**

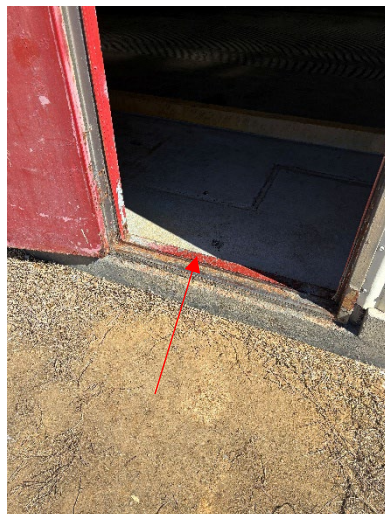
**Door Threshold
Hangar (Side B)**

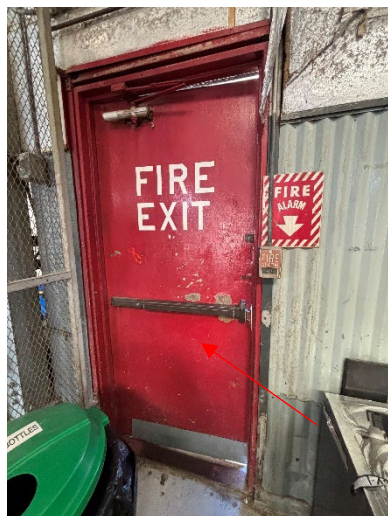
**Door
Maintenance (Side D)**

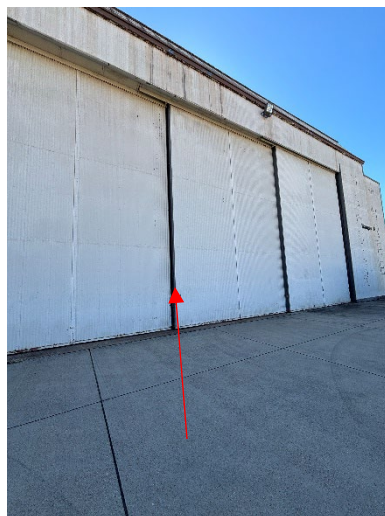
- Grey Painted Metal Sliding Hangar Door Trim on Side C of the building.

**Sliding Door Trim
Exterior (Side C)**
