PROJECT NUMBER **621-24-701 (2409)**
PROJECT NAME **EHRM Infrastructure Upgrades – Tier 3 DC
Mountain Home, TN**
SUBMITTAL **Final Bid Documents**
SUBJECT **Environmental Design Narrative**

1.0 Project Overview and Background

3.0 Initial RSH Asbestos Investigation Findings

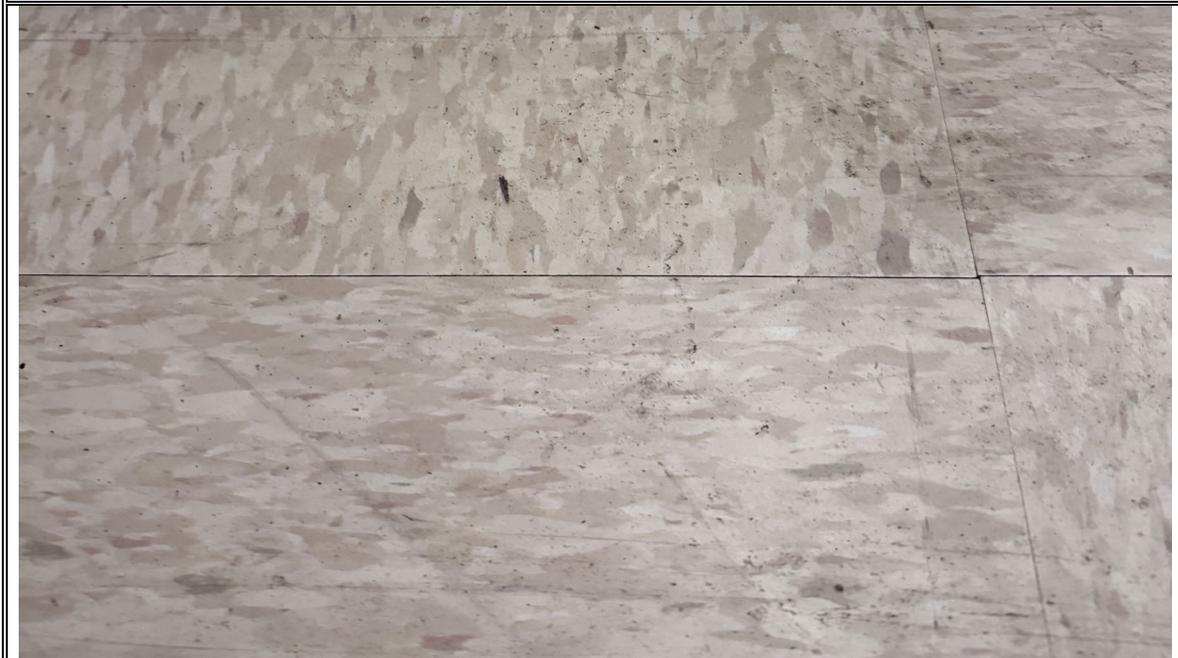
12"x12" Cream w/ Beige Splotches FT w/ Yellow Mastic, Rooms 3A-113, 3A-113A, Samples A04 to A06, Non-ACM

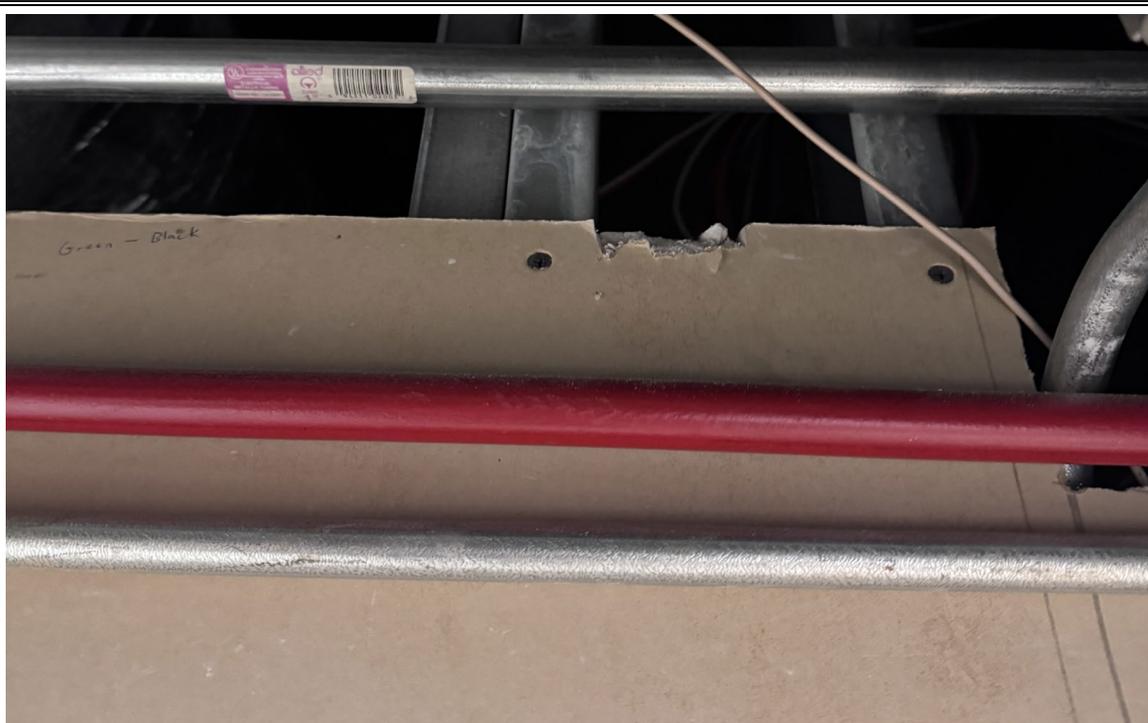
Drywall - White, Rooms 3A-113, 3A-113A, Samples A07 to A09, Non-ACM

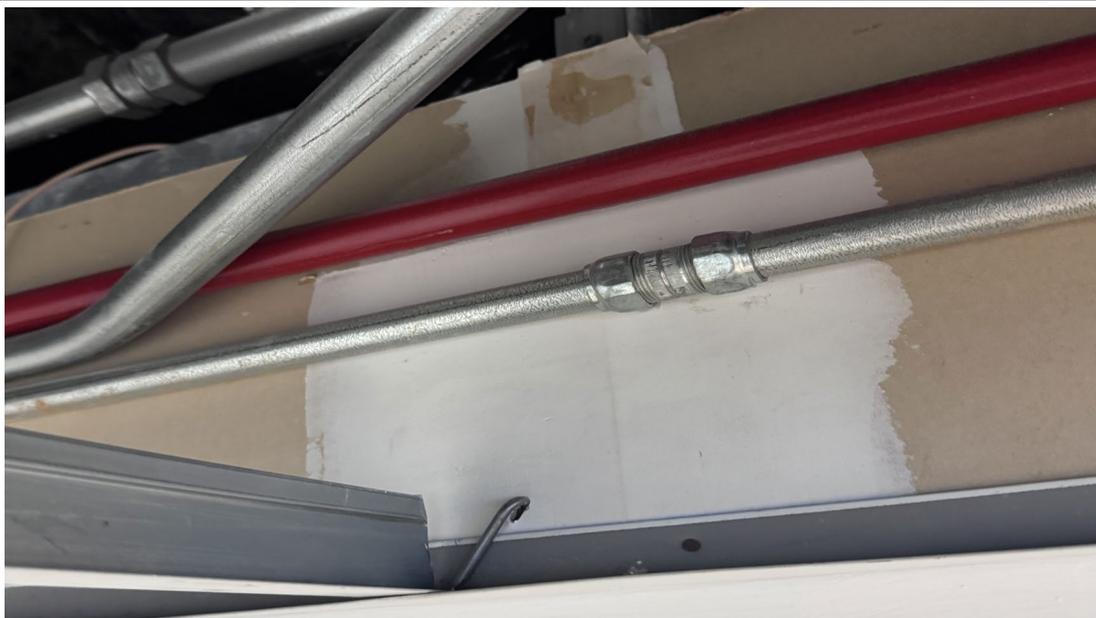
Drywall Joint Compound - White, Rooms 3A-113, 3A-113A, Samples A10 to A12, Non-ACM

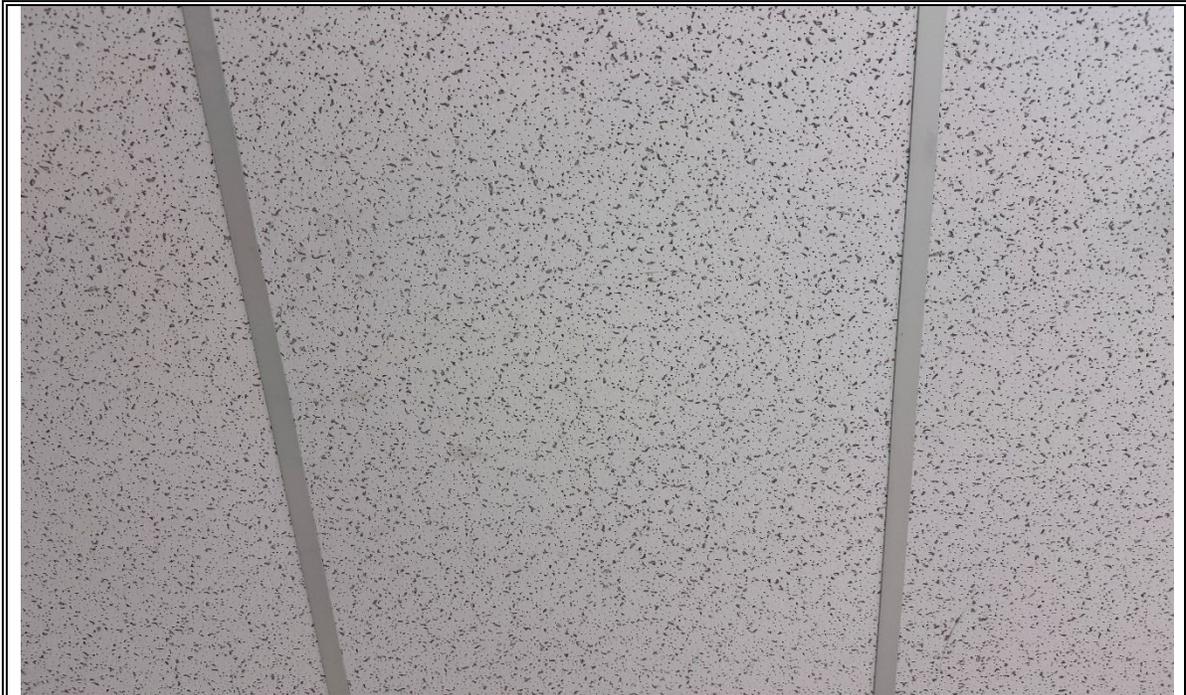
2'x4' Ceiling Tile w/ Medium Pinholes and Small Fissures, Rooms 3A-113, 3A-113A, Samples A13 to A15, Non-ACM

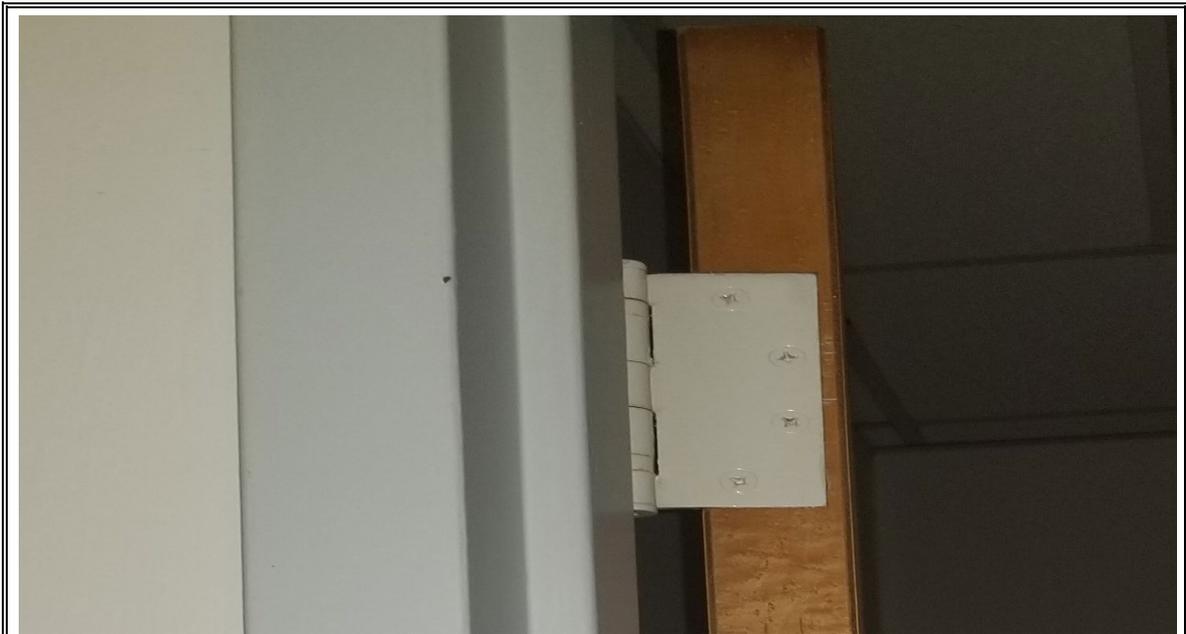
Door Frame Caulk - White, Rooms 3A-113, 3A-113A, Samples A16 to A18, Non-ACM

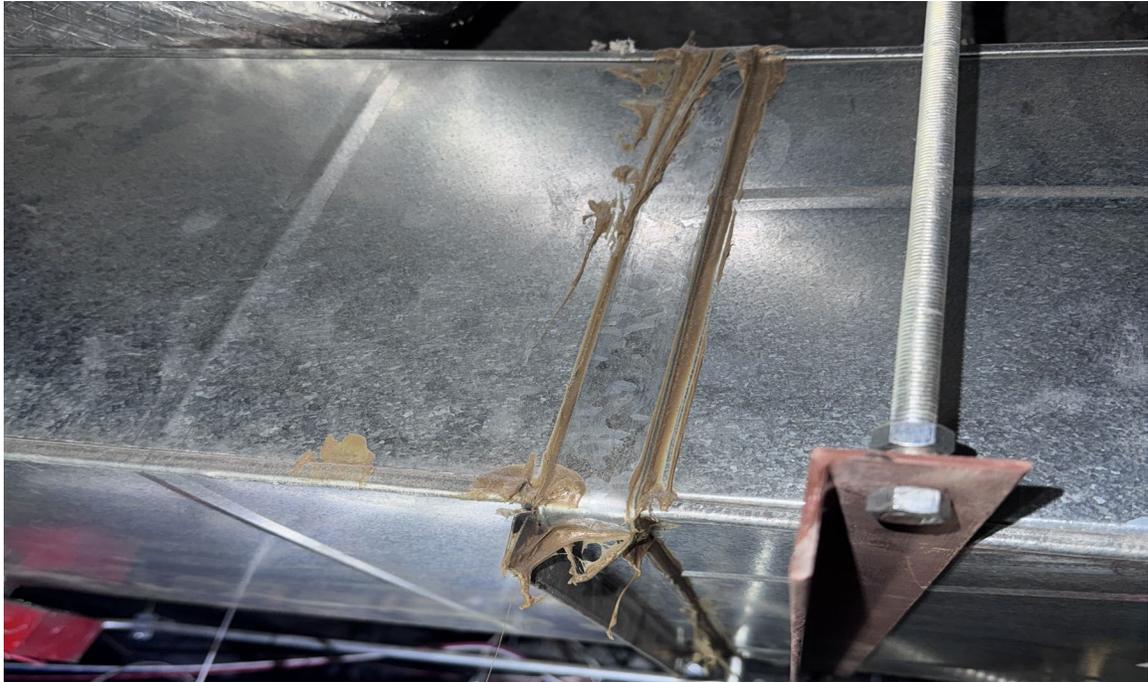
- **Tan Seam Sealant on both Return Air and Supply Air Ducts** above ceilings throughout the areas within the scope of work (SOW) and to areas leading to or near the SOW.
- **Black Mastic** was found under the floor tile or carpet in Rooms 3A-112, 3A-112 Closet, 3A-107, 3A-108, and the Hallway outside the SOW.

**Tan Seam Sealant on RA Duct, Room 3A-113A, Samples A19 to A21, 2%
Chrysotile, Category II Nonfriable ACM**

Multiple asbestos-containing items will be impacted by The Project and will require abatement prior to any other work. These items include residual black floor tile mastic, tan duct seam sealant, PACM fire doors, and PACM historic hidden window caulking.

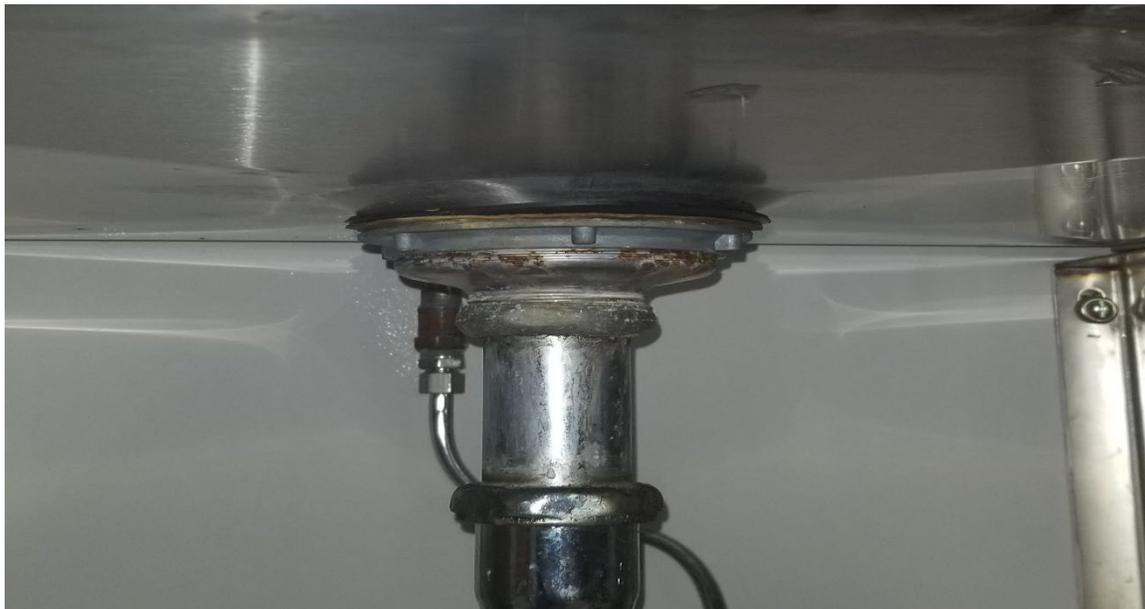
**Black/Cardboard Stainless Steel Sink Gasket, Room 3A-113A, Samples A22 to
A24, Non-ACM**

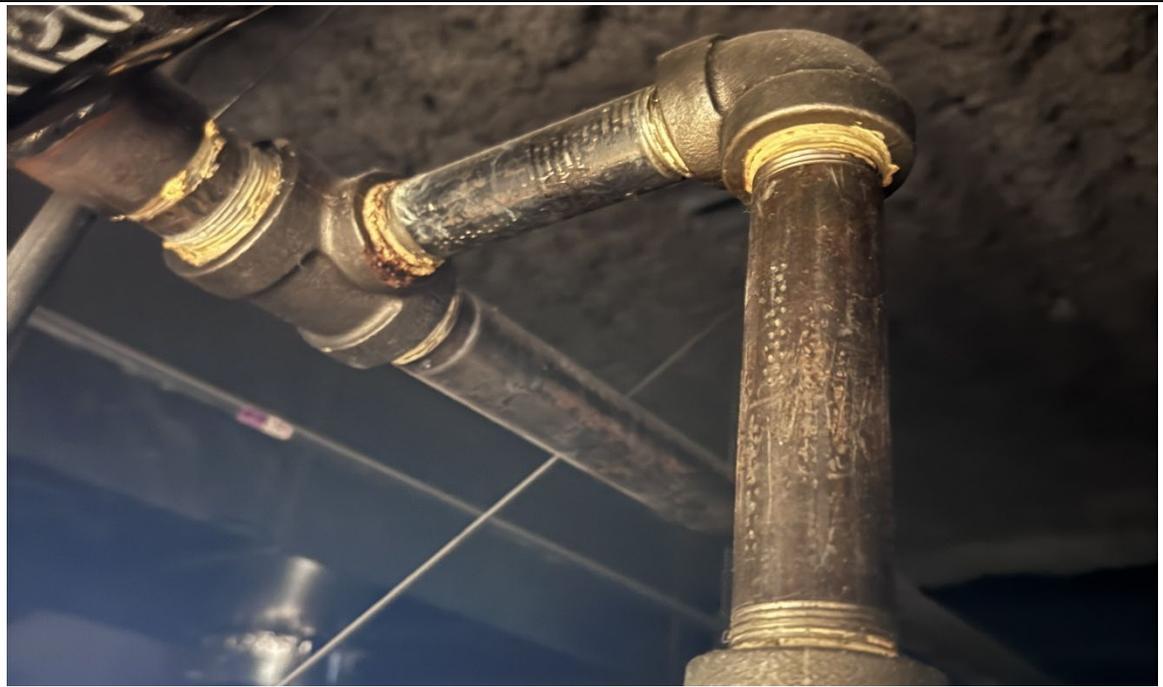
Beige Pipe Dope on Fire Sprinkler Line, Room 3A-113, Samples A25 to A27, Non-ACM

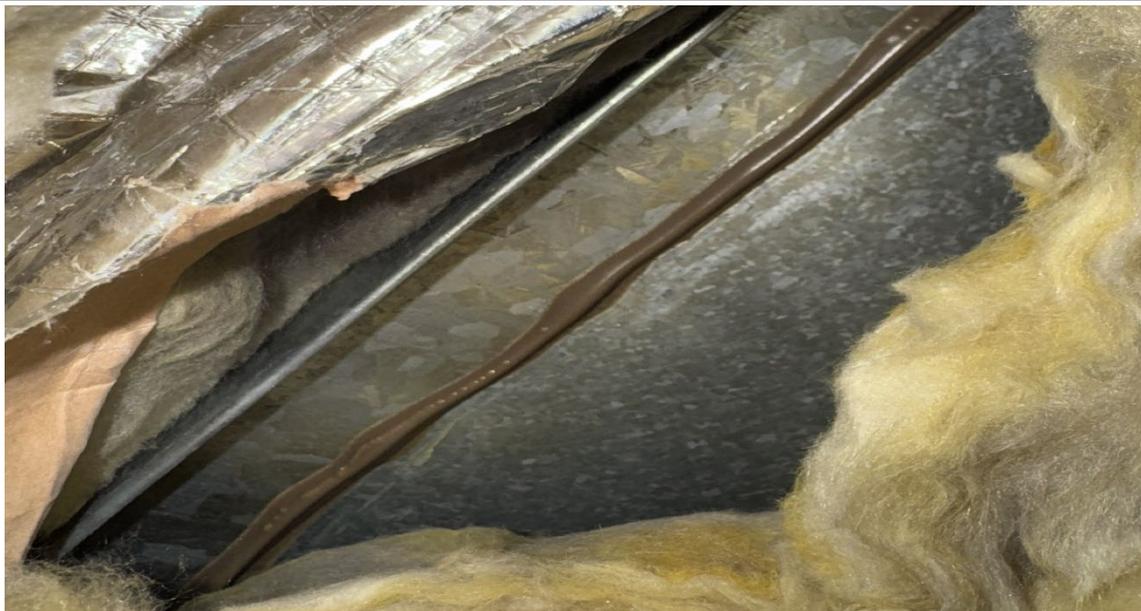
Tan Seam Sealant on SA Duct, Room 3A-113, Samples A28 to A30, 2-3% Chrysotile, Category II Nonfriable ACM

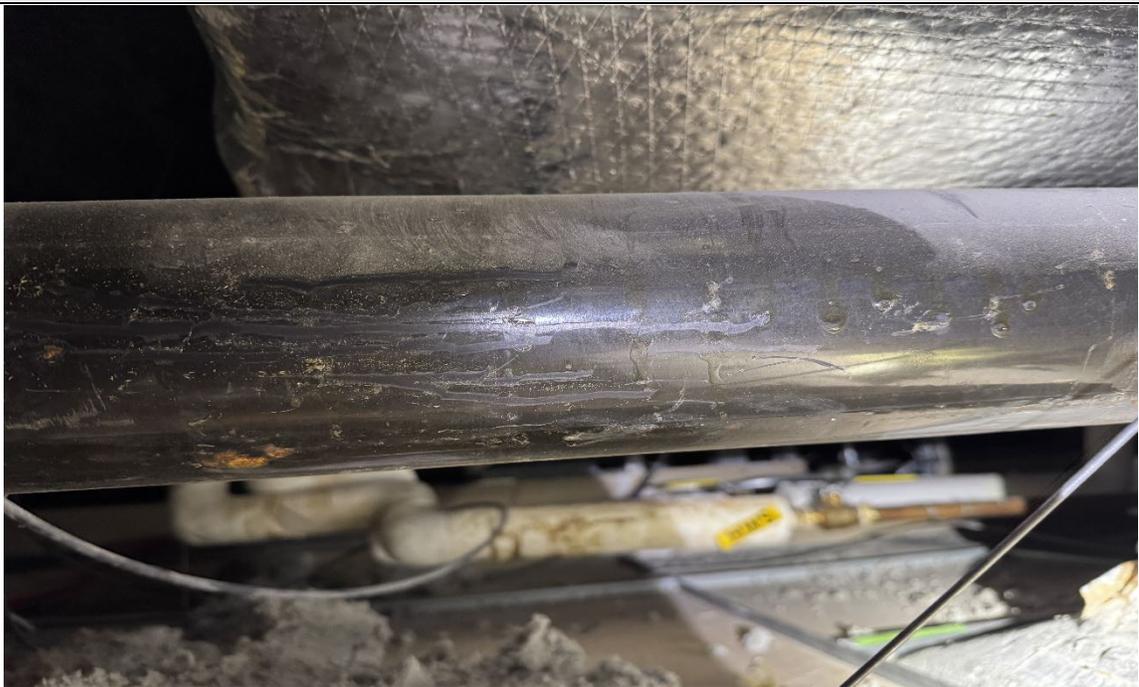
Brown Coating on Fire Sprinkler Main, Room 3A-113, Samples A37 to A39, Non-ACM

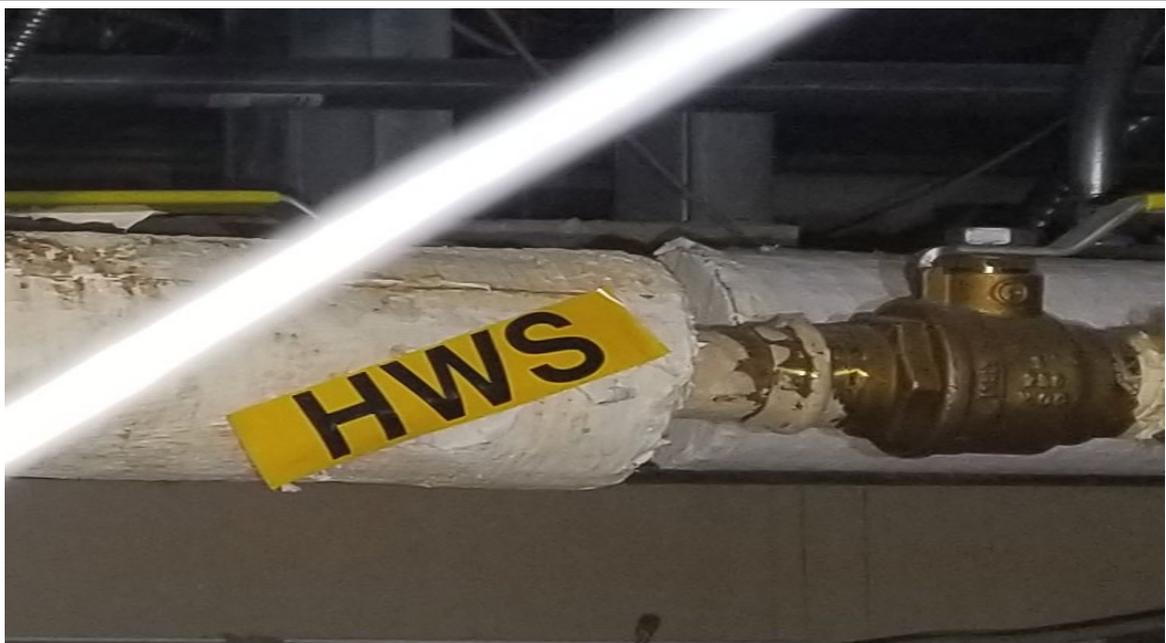
White Seam Sealant on HWS Line, Room 3A-113 Samples A40 to A42, Non-ACM

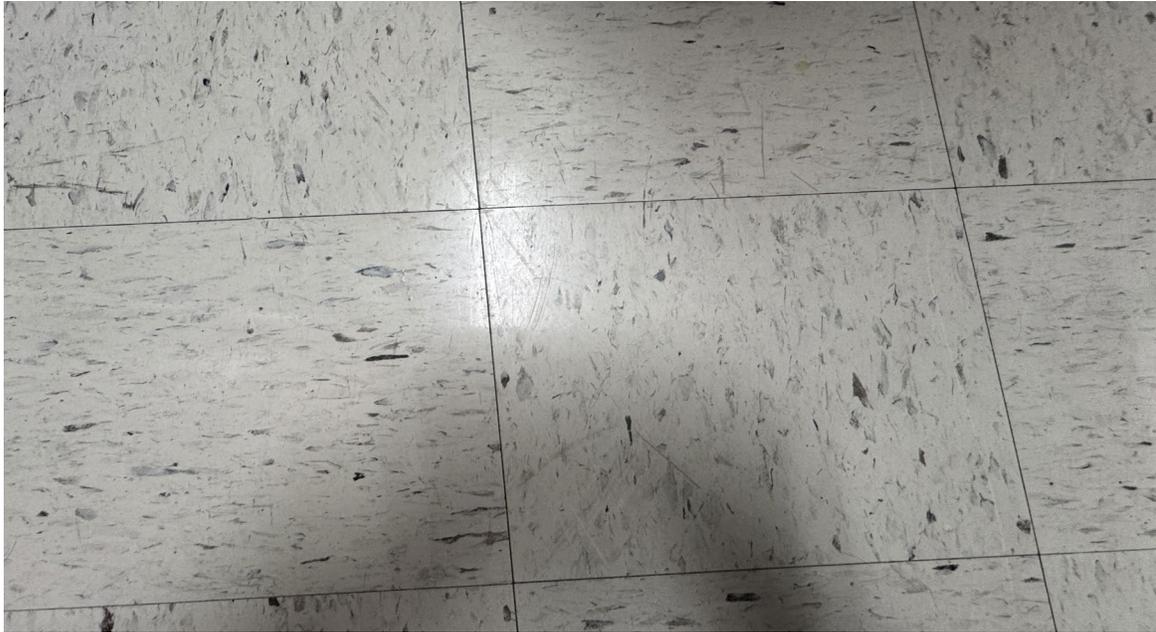
12x12 White w/ Blue & Green Flecks w/ Yellow and Black Mastic, Room 3A-112 (Closet), Samples A43 to A45, Black Mastic 4-9% Chrysotile, Category I Nonfriable ACM

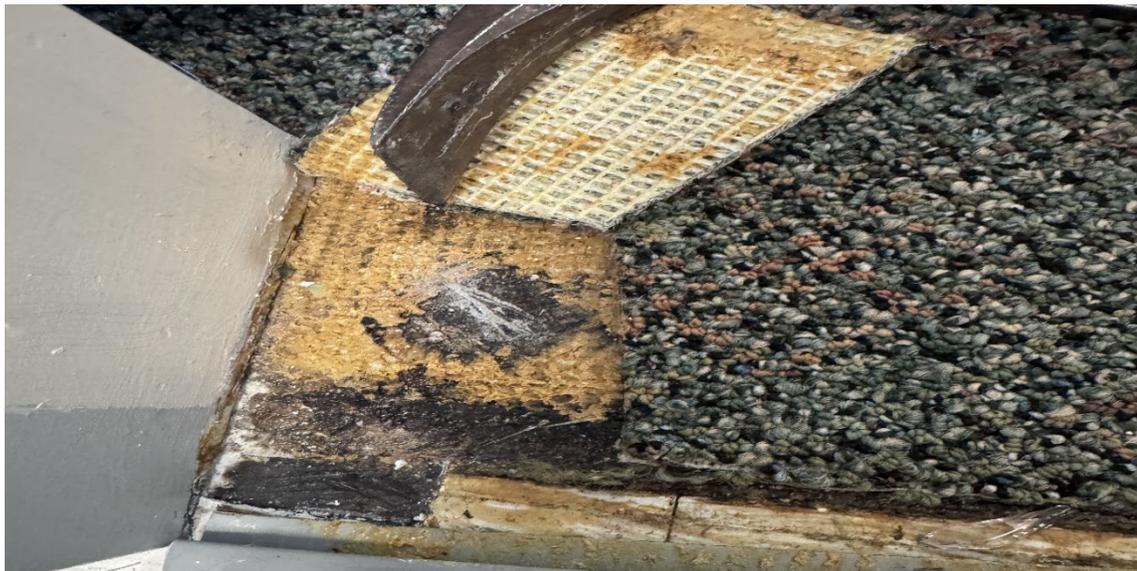
Yellow Carpet Mastic and Residual Black Mastic under Green Multicolor Roll Out Carpet, Room 3A-112, Samples A46 to A48, Black Mastic 5-7% Chrysotile, Category I Nonfriable ACM

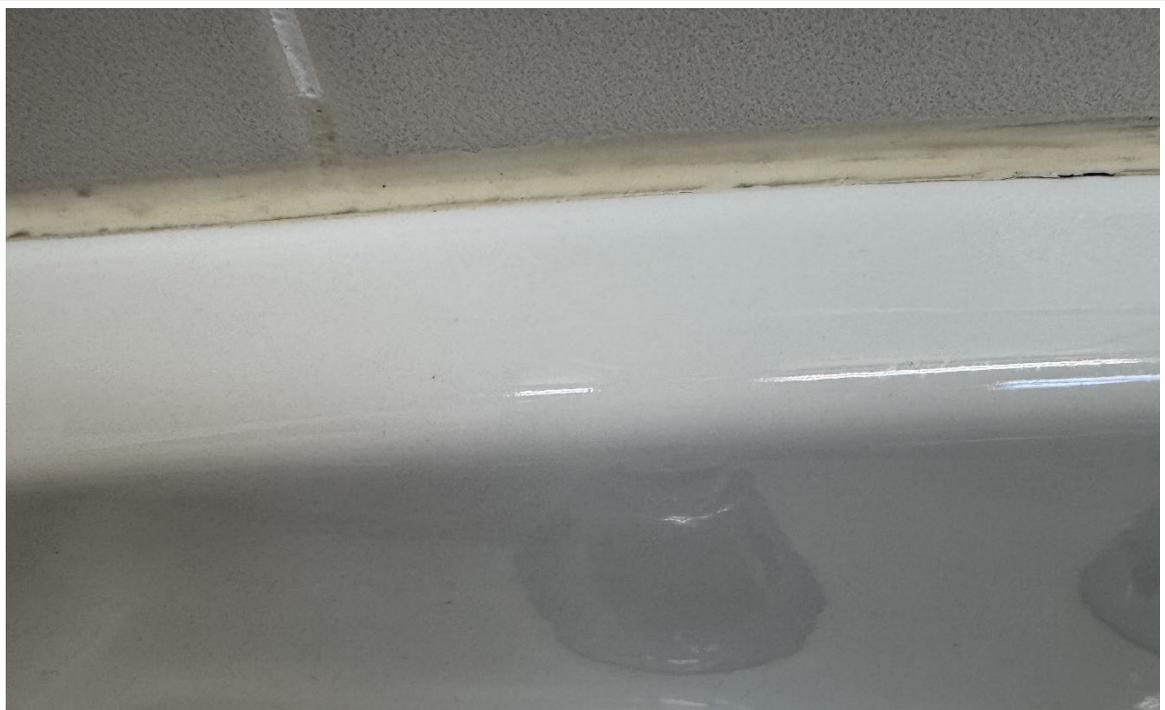
Sink Fixture Caulk – White, Room 3A-112D, Samples A52 to A54, Non-ACM

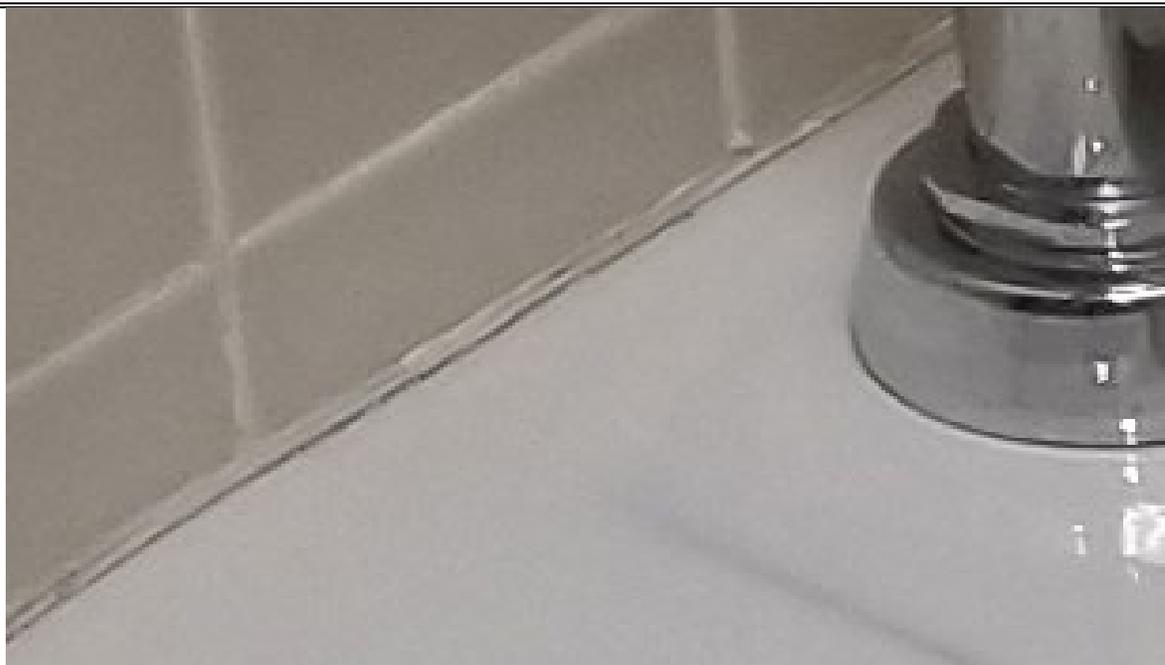
Toilet Fixture Caulk – White, Room 3A-112D, Samples A55 to A57, Non-ACM

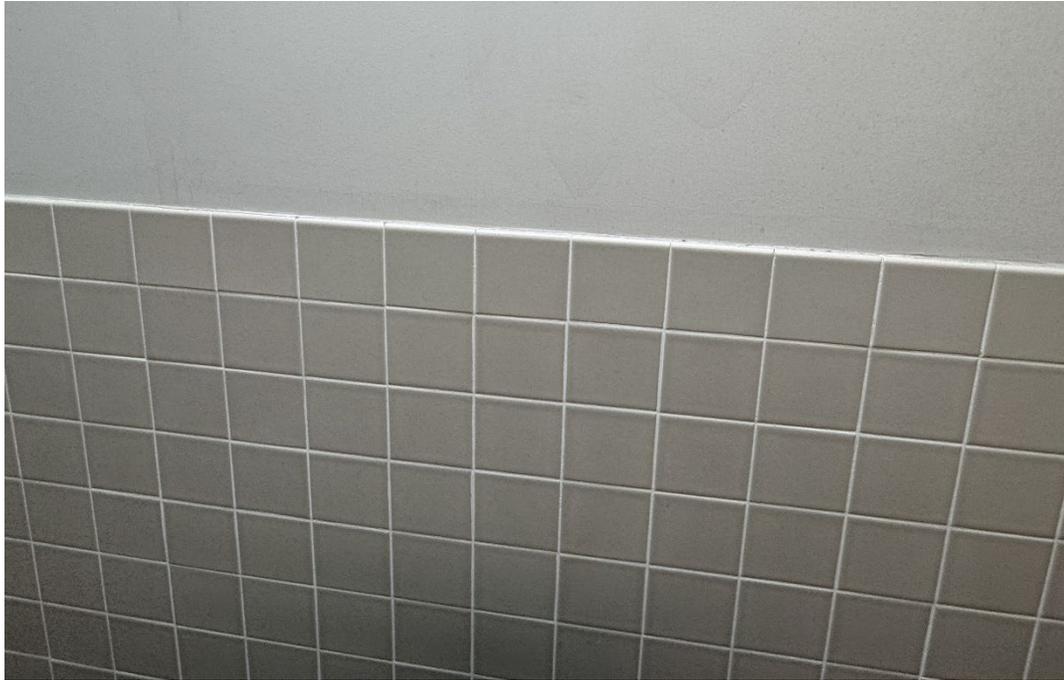
White Caulk assoc w/ 4x4 Beige CWT, Room 3A-112D, Samples A58 to A60, Non-ACM

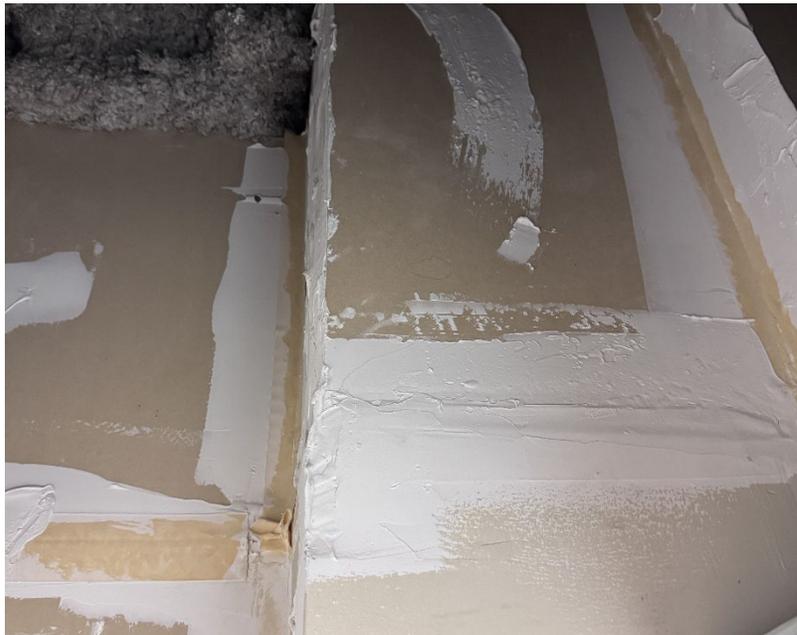
Drywall Tape - White, Rooms 3A-112, 3A-112D, Samples A61 to A63, Non-ACM

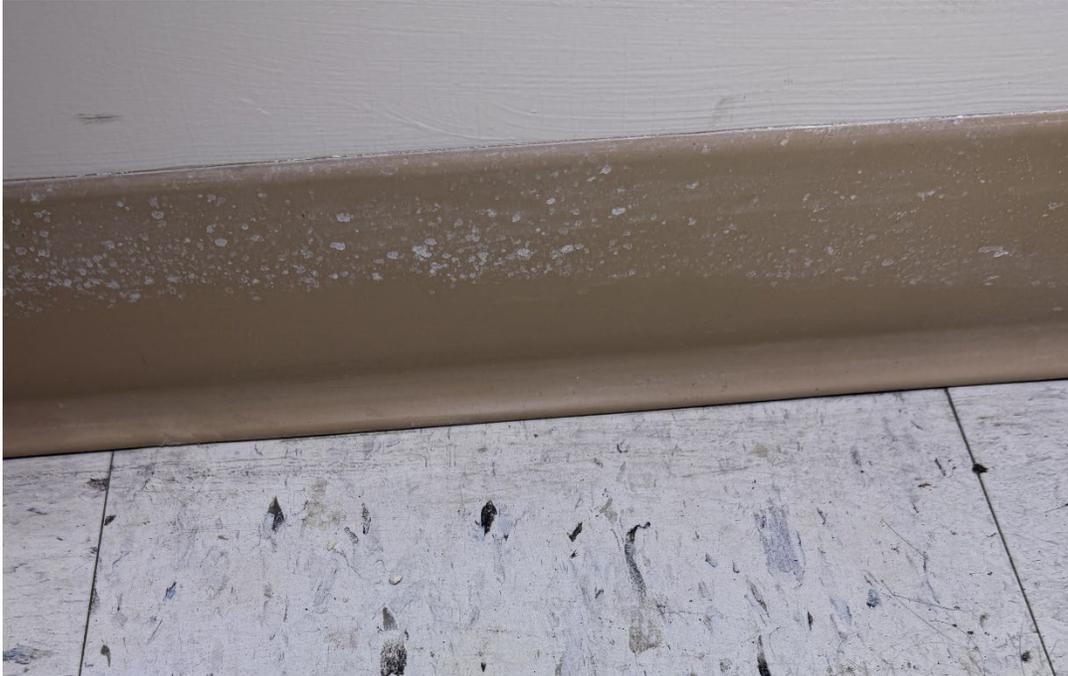
4" Tan/Orange Cove Base w/ Yellow Mastic, Room 3A-112 (Closet), Samples A73 to A75, Non-ACM

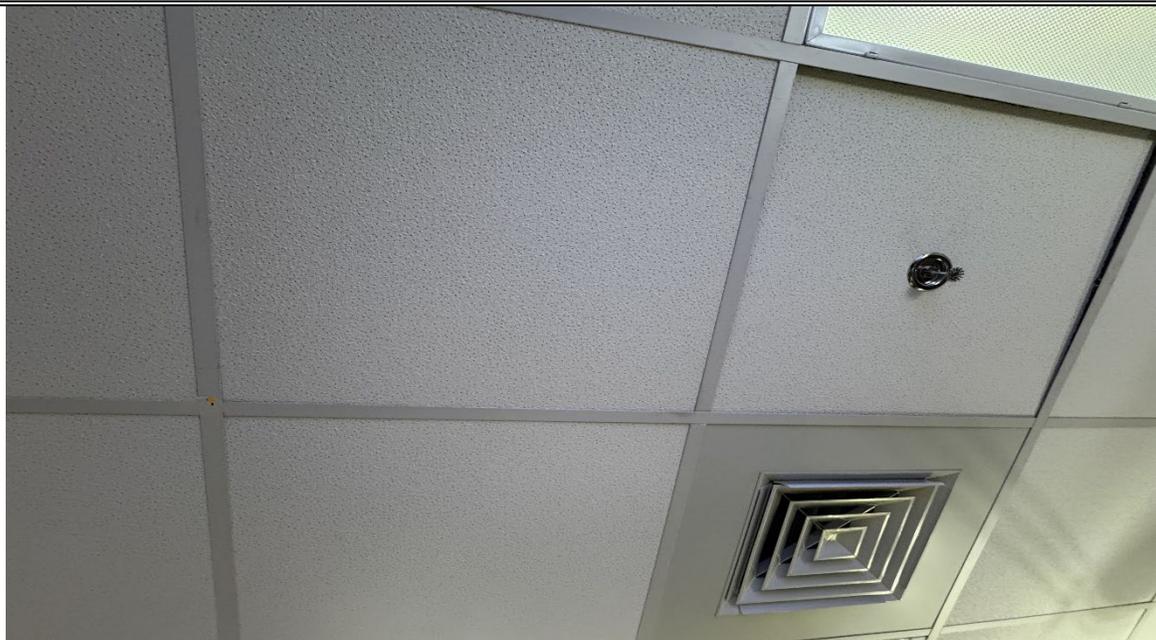
2x2 Ceiling Tile – Small Pinholes, Room 3A-212, Samples A76 to A78, Non-ACM

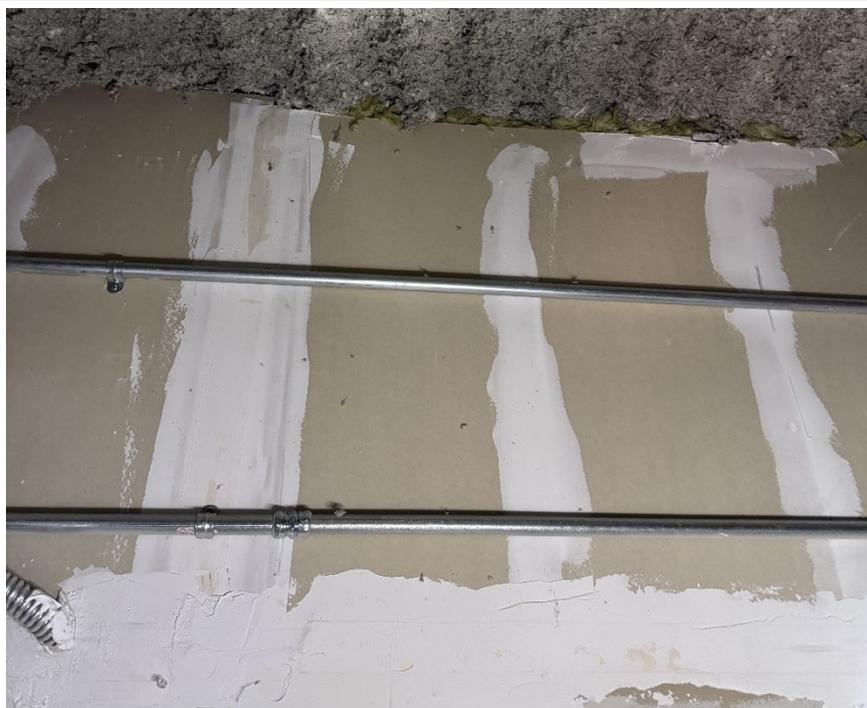
Drywall Joint Compound – White, Room 3A-212, Samples A79 to A81, Non-ACM

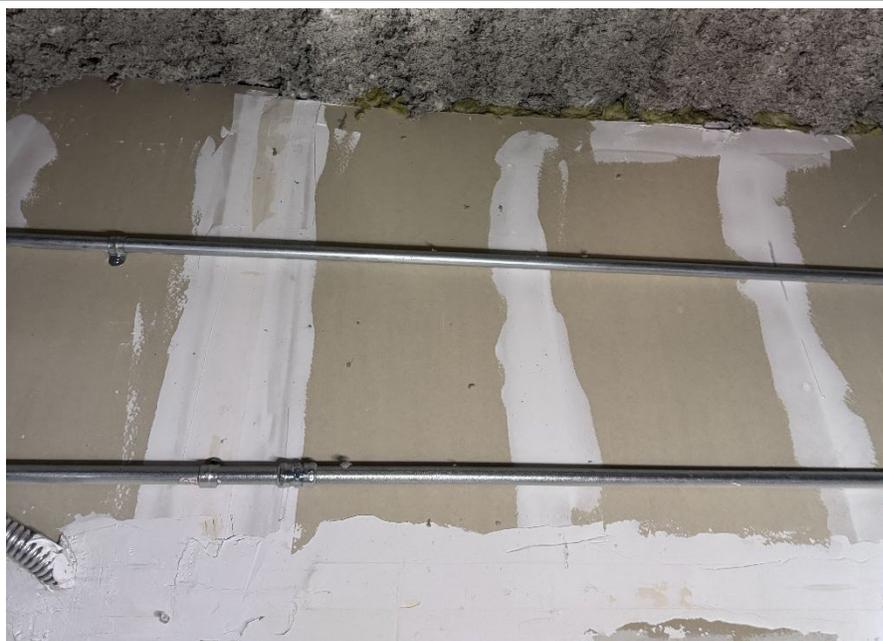
Drywall - White, Room 3A-212, Samples A82 to A84, Non-ACM

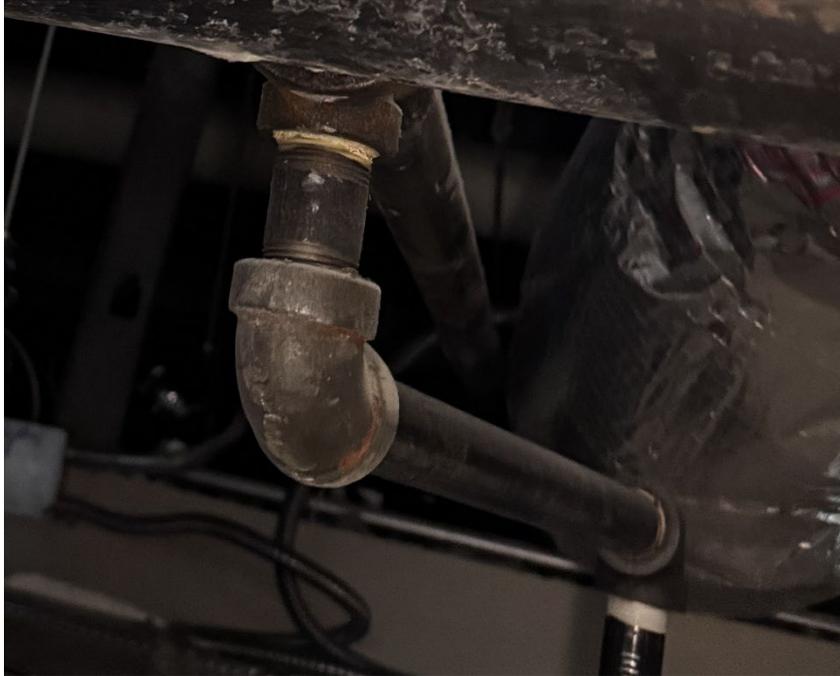
White Pipe Dope on Fire Sprinkler Line, Room 3A-212, Samples A55 to A57, Non-ACM

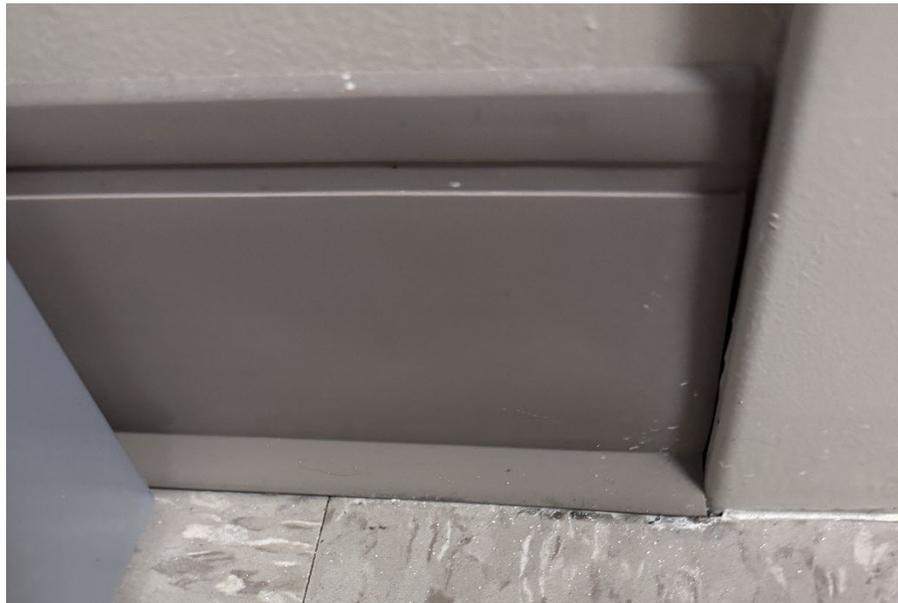
4" Tan w Line Cove Base w Yellow Mastic, Room 3A-212, Samples A88 to A90, Non-ACM

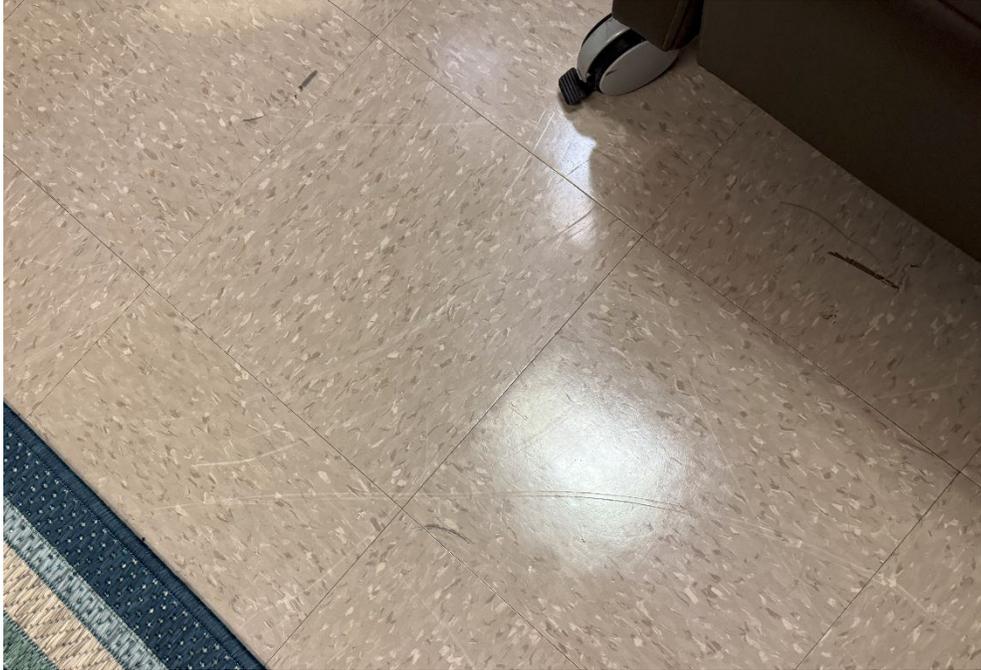
12x12 Tan w Cream Splotches FT w Yellow Mastic, Room 3A-212, Samples A91 to A93, Non-ACM

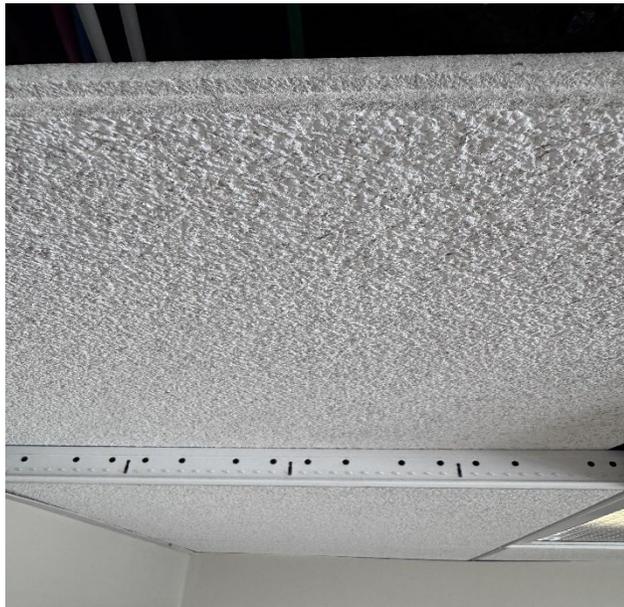
2x2 Textured Ceiling Tile, Hallway outside Room 3A-214, Samples A100 to A102, Non-ACM

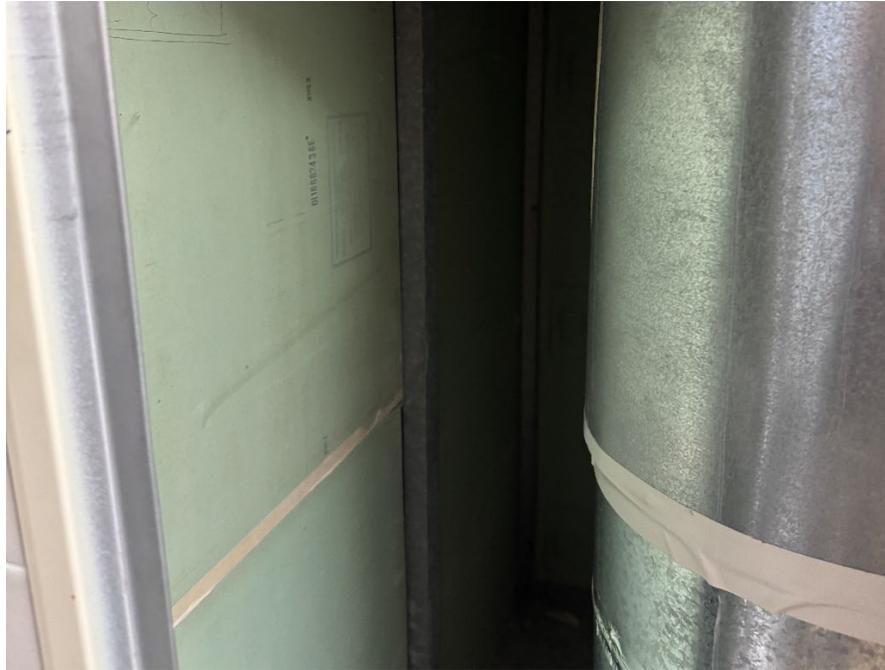
**Fire-Rated Wallboard - Green, Room 3A-114 (Lined Shaft for Garbage Chute),
Samples A103 to A105, Non-ACM**

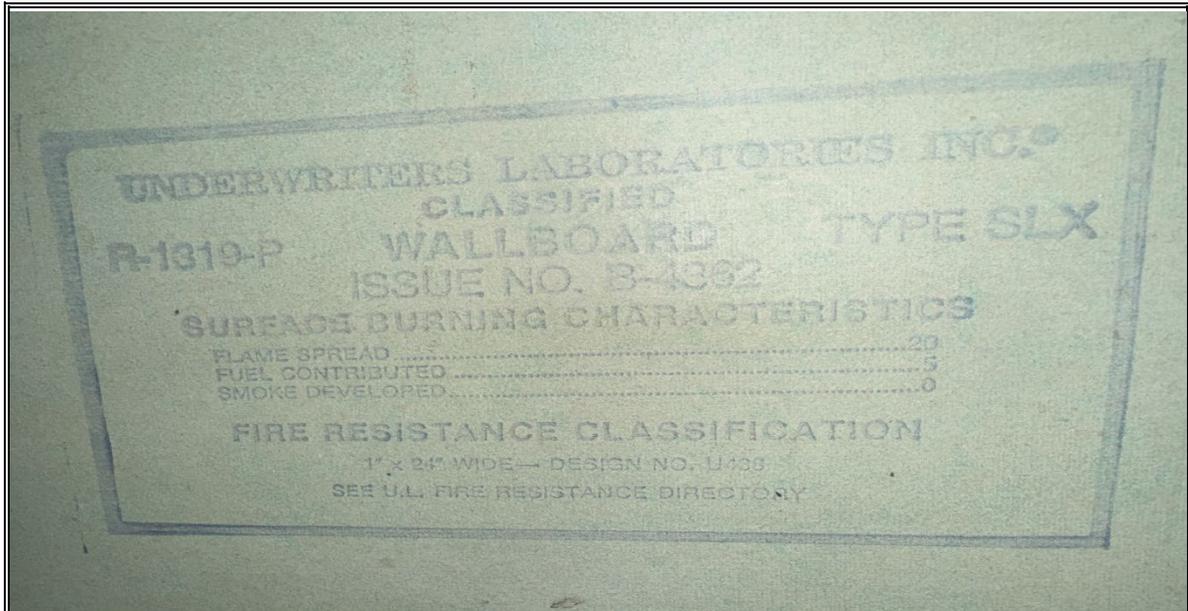
**Fire-Rated Wallboard - Green, Room 3A-114 (Lined Shaft for Garbage Chute),
Samples A103 to A105, Non-ACM**

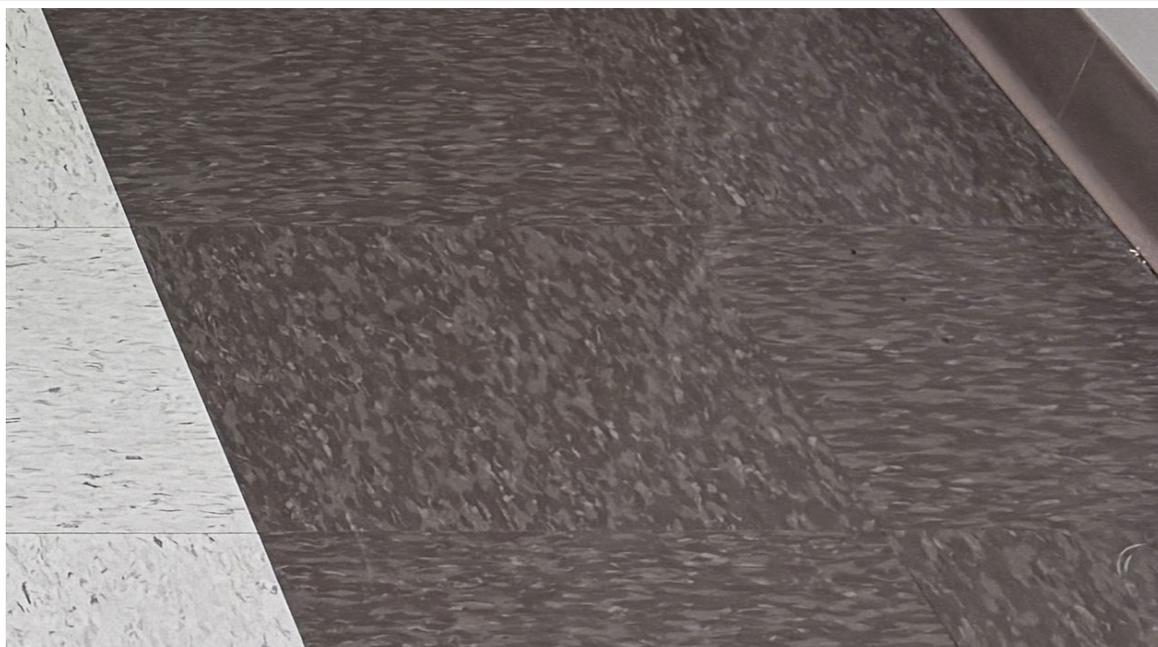
12x12 Dk Brown Accent Floor Tile w/ Black Mastic, Hallway outside Room 3A-110, Samples A121 to A123, Black Mastic 6-7% Chrysotile, Category I Nonfriable ACM

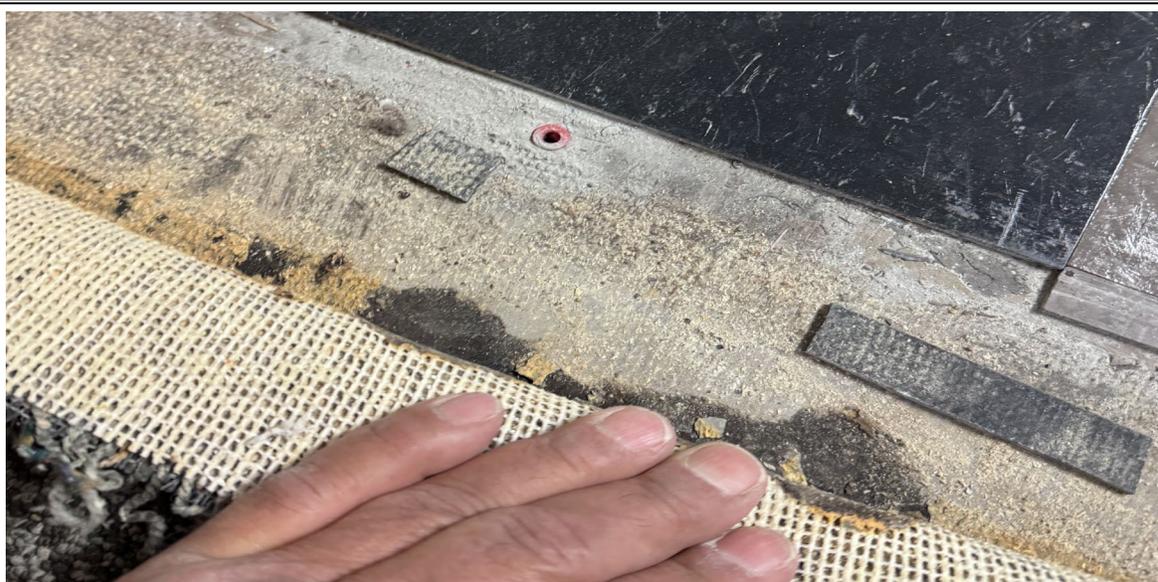
Yellow and Black Carpet Mastic assoc w/ Green and Yellow Rollout Carpet, Room 3A-108, Samples A130 to A132, Black Mastic 5-9% Chrysotile, Category I Nonfriable ACM

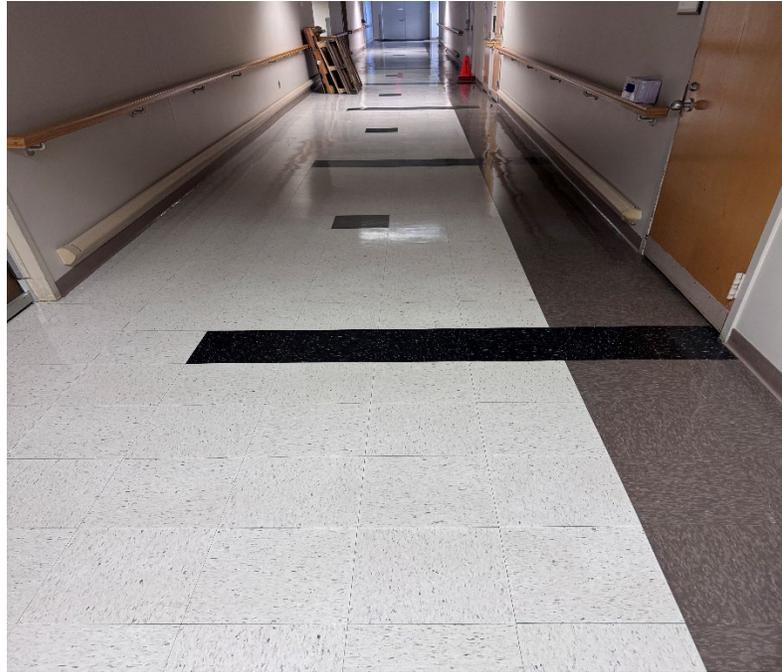
12x12 White w/ Gray Specks Floor Tile w/ Black Mastic, Hallway outside Room 3A-108, Sample 138, Black Mastic 5% Chrysotile, Category I Nonfriable ACM

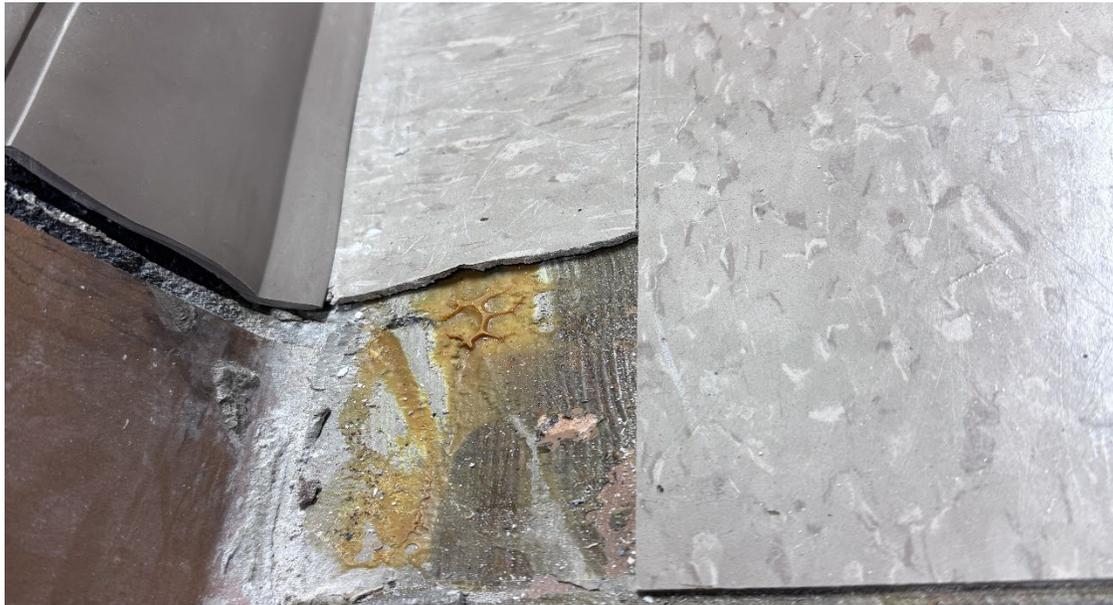
12x12 Gray w/ Cream Splotches Floor Tile w/ Yellow Mastic, Room 3A-221, Samples A142 to 144, Non-ACM

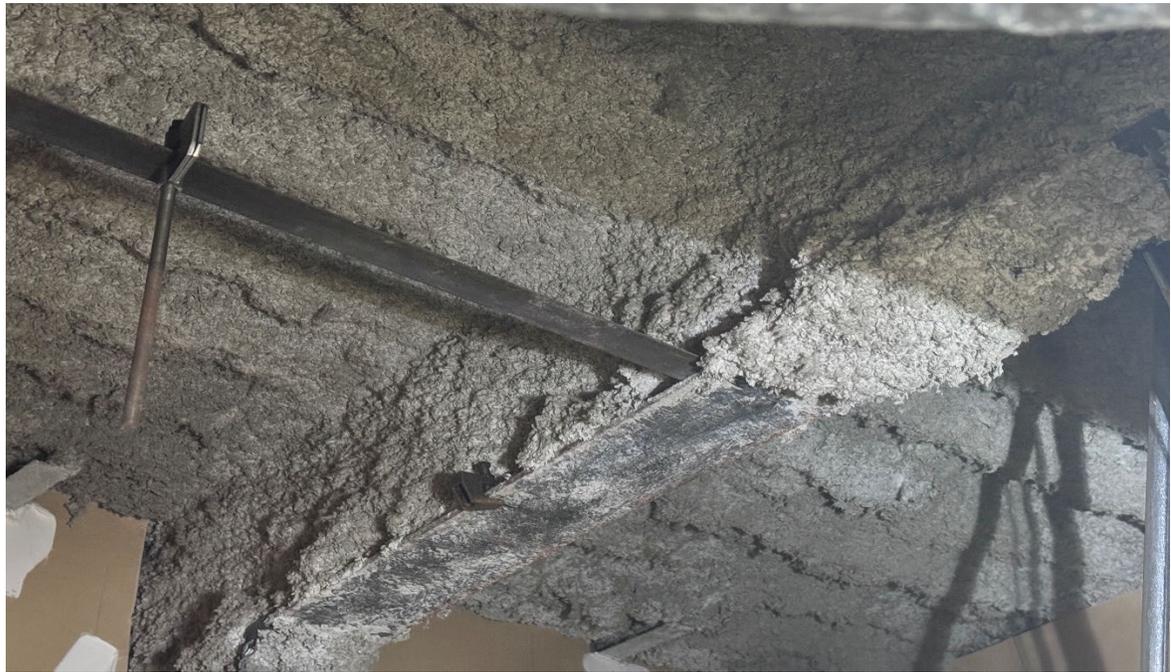
**Gray Spray On Fireproofing, Rooms 3A-113, 3A-212, 3A-110,3A-107, and 3A-212,
Samples A149 to A156, Non-ACM**
