Report of Pre- Demolition Asbestos Survey  
and Lead-Based Paint Screen

Military Working Dog Kennel  
Hunter Army Airfield  
Savannah, Georgia  
Geo-Hydro Project Number 200183.30

*Burns & McDonnell*  
*March 20, 2020*

**Report of  
Pre-Demolition Asbestos  
and Lead-Based Paint Survey  
Military Working Dog Kennel  
Hunter Army Airfield  
Savannah, Georgia  
Geo-Hydro Project Number 200183.30**

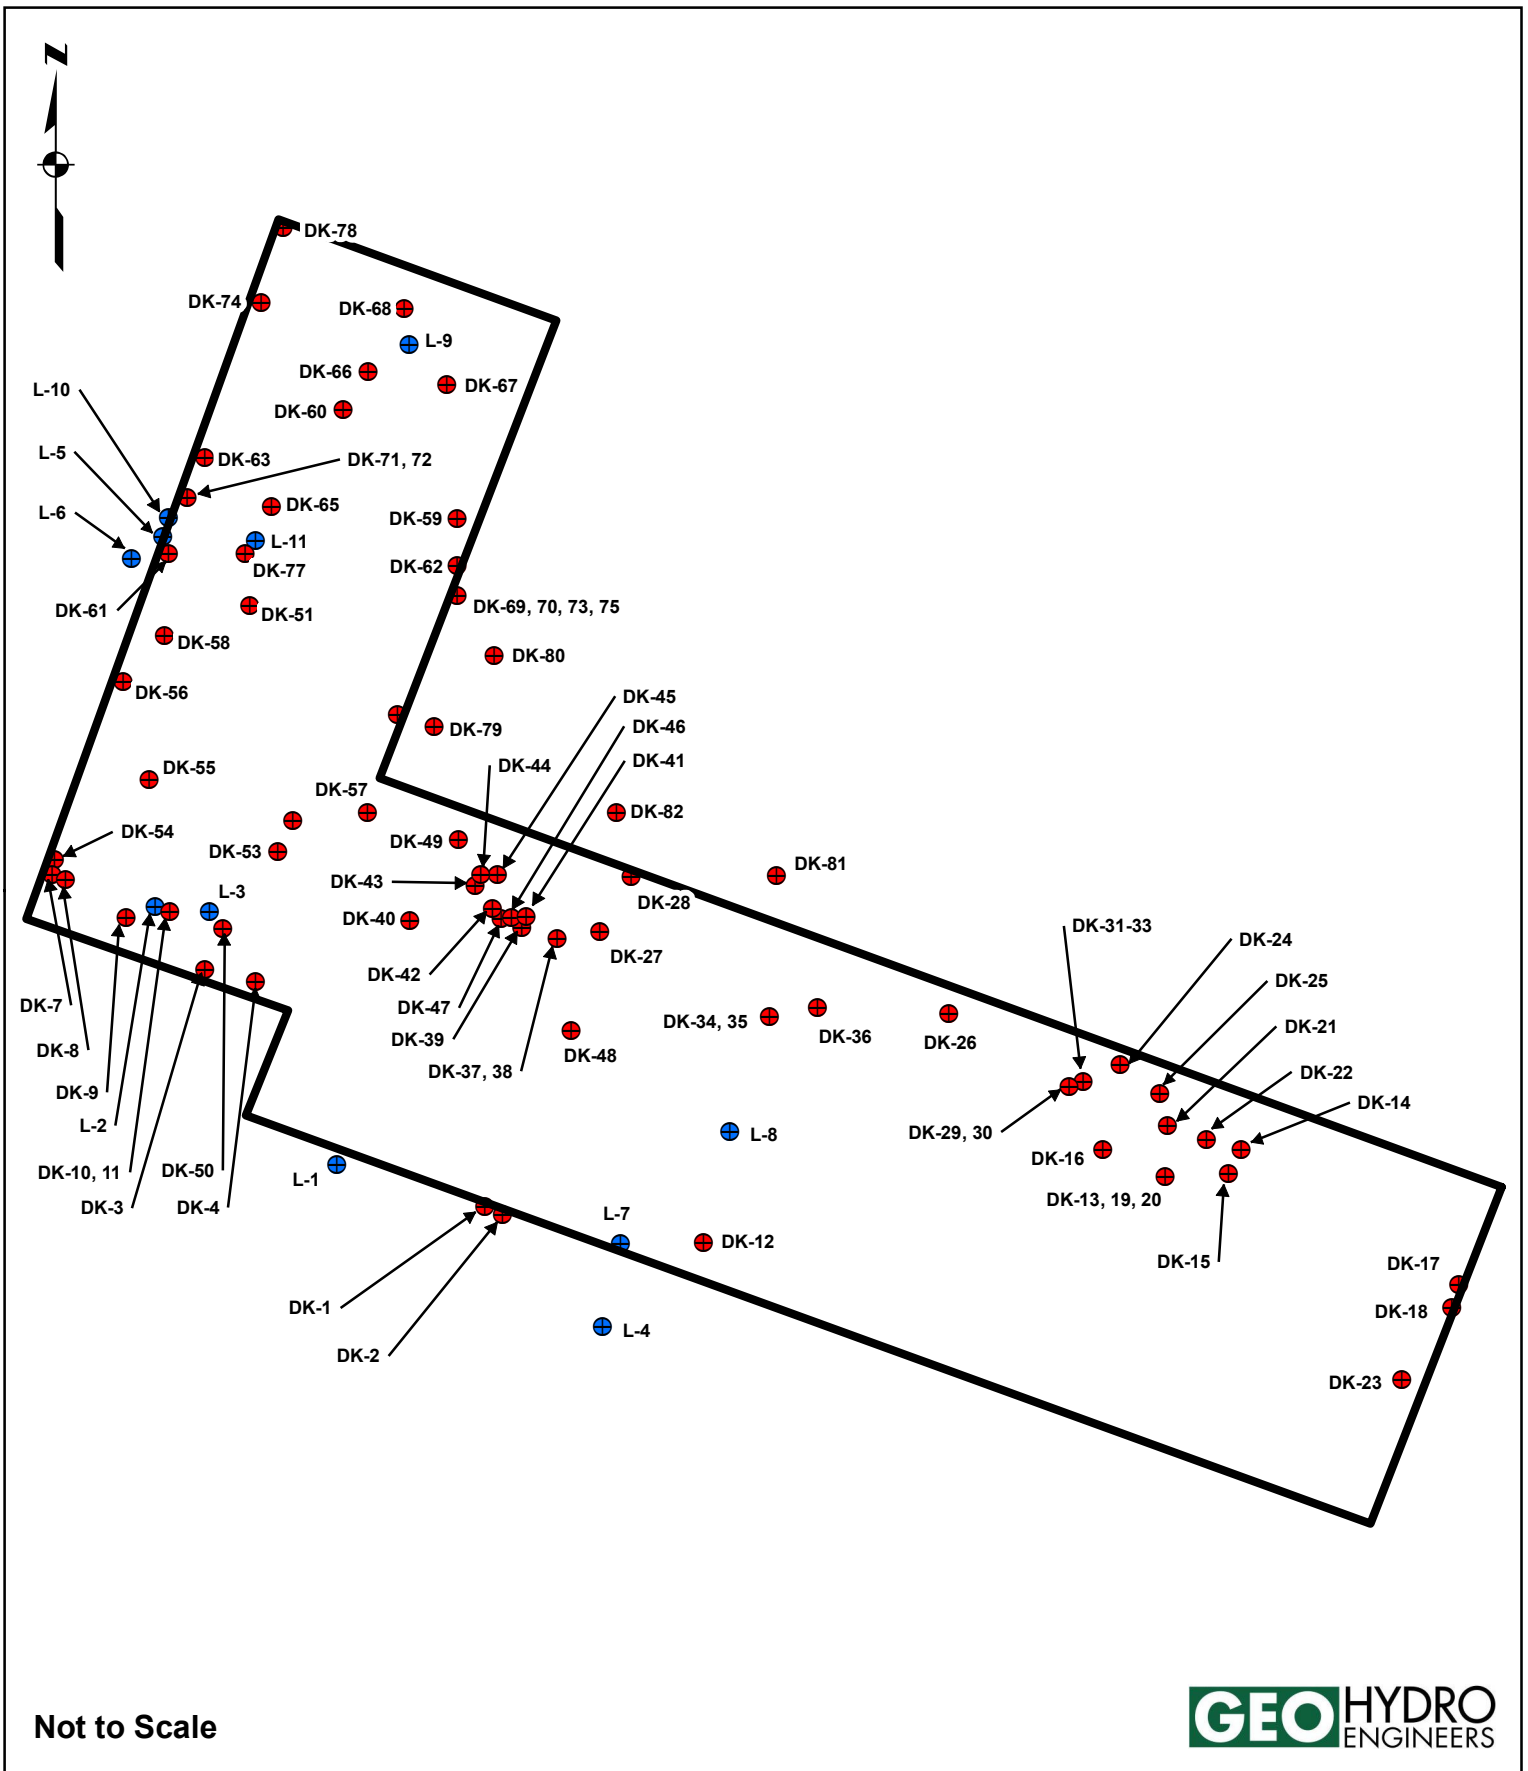
**Figure 2: Sample Location Map**

A total of 82 samples of suspect ACMs including floor tiles, drywall system components, glue, and other materials, were collected from the subject property. The suspect ACM samples were submitted to Analytical Environmental Services, Inc. (AES) in Atlanta, Georgia. AES is accredited by the National Voluntary Laboratory Accreditation Program (NVLAP) and the American Industrial Hygiene Association (AIHA) for bulk asbestos fiber analysis. The samples were analyzed for asbestos content using polarized light microscopy (PLM) and dispersion staining (EPA Method 600/R-93/63). Sample locations are shown on Figure 2, which is included in the Appendix.

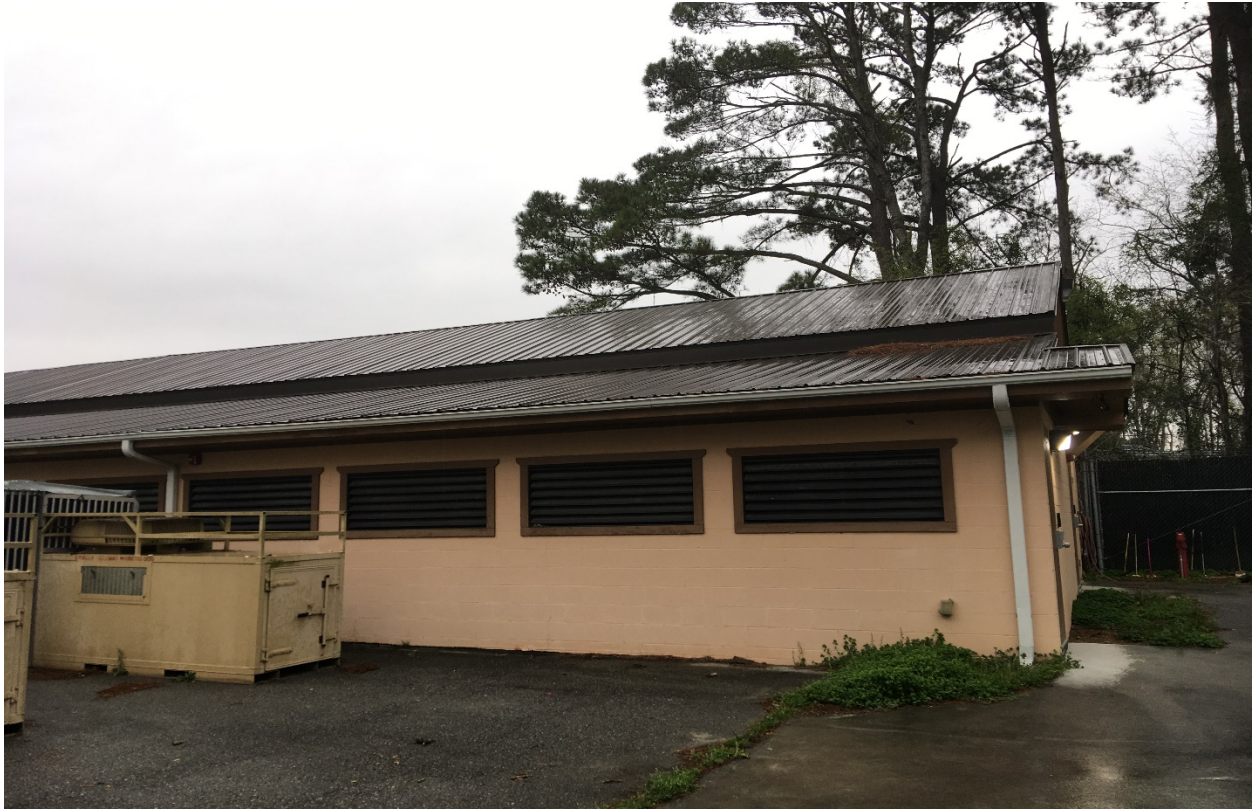
Plate 1: The subject property consists of an approximately 9,000-square foot Working Dog Kennel and associated veterinarian spaces located at the Hunter Army Airfield in Savannah, Georgia. Above is the area where kennels are located.

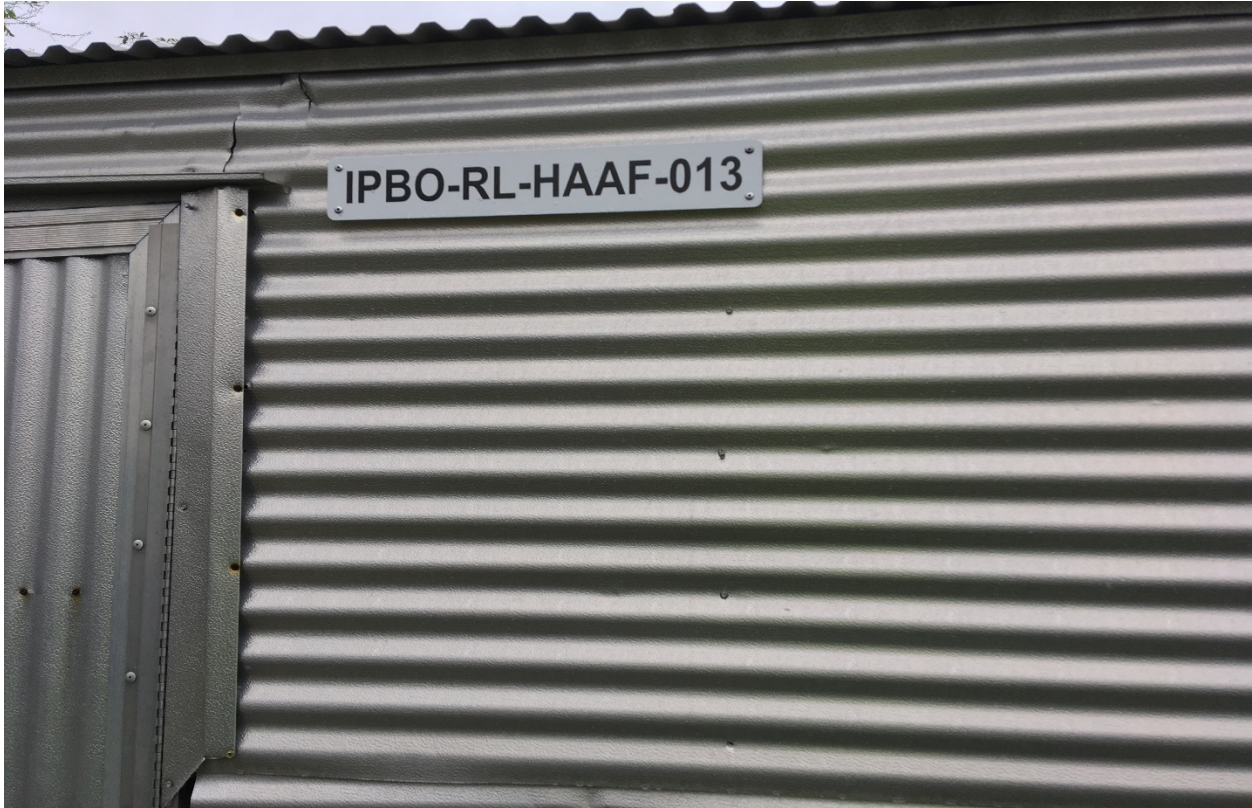
The subject property also had two corrugated metal sheds (Plates 2 - 4). No suspect ACM was identified on the exteriors of the two sheds. From holes in the walls of each of the sheds, the interiors of these sheds appeared to be unfinished. However, the interiors of the two sheds were inaccessible. Geo-Hydro recommends having the interiors of the two sheds inspected for suspect ACM before demolition.

Plate 2: The subject property consists of an additional two steel corrugated metal storage units not operated by the Working Dog Kennel personnel.

No suspect ACM was identified on the exteriors of the two corrugated metal sheds. From holes in the walls of each of the sheds, the interiors of these sheds appeared to be unfinished. However, the interiors of the two sheds were inaccessible. Geo-Hydro recommends having the interiors of the two sheds inspected for suspect ACM before demolition.

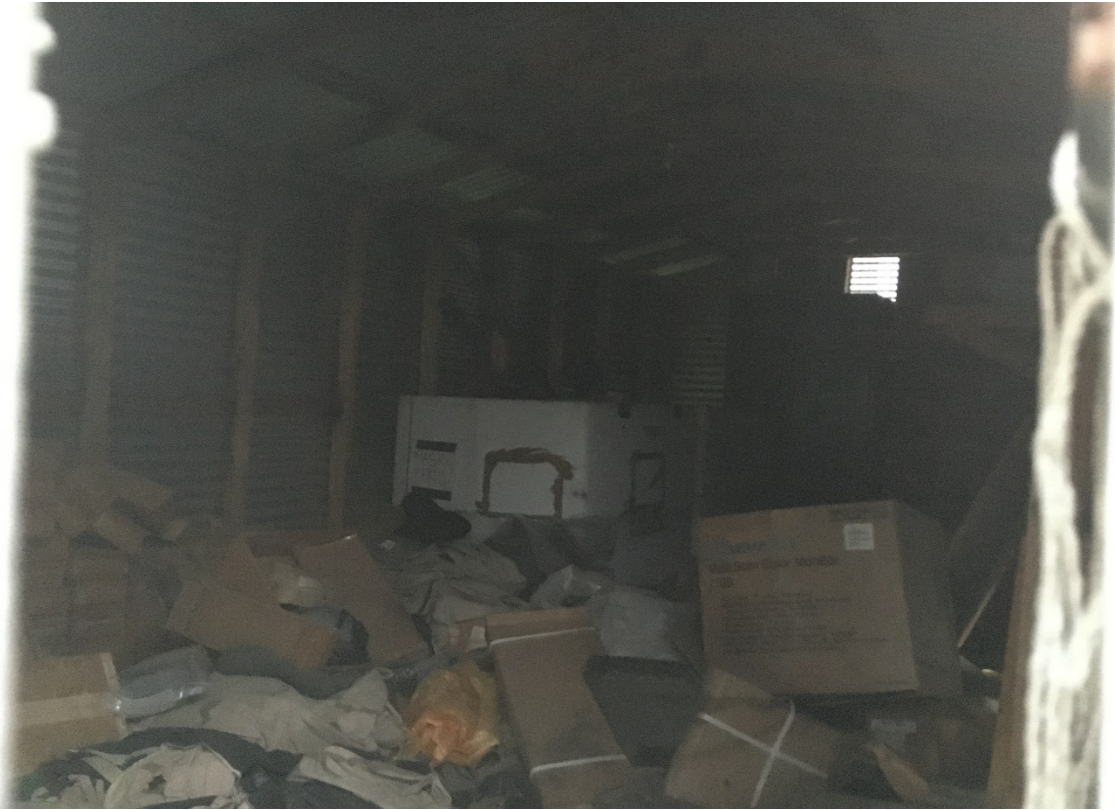
Plate 3: Interior of one of the metal sheds with less damage observed to the exterior.

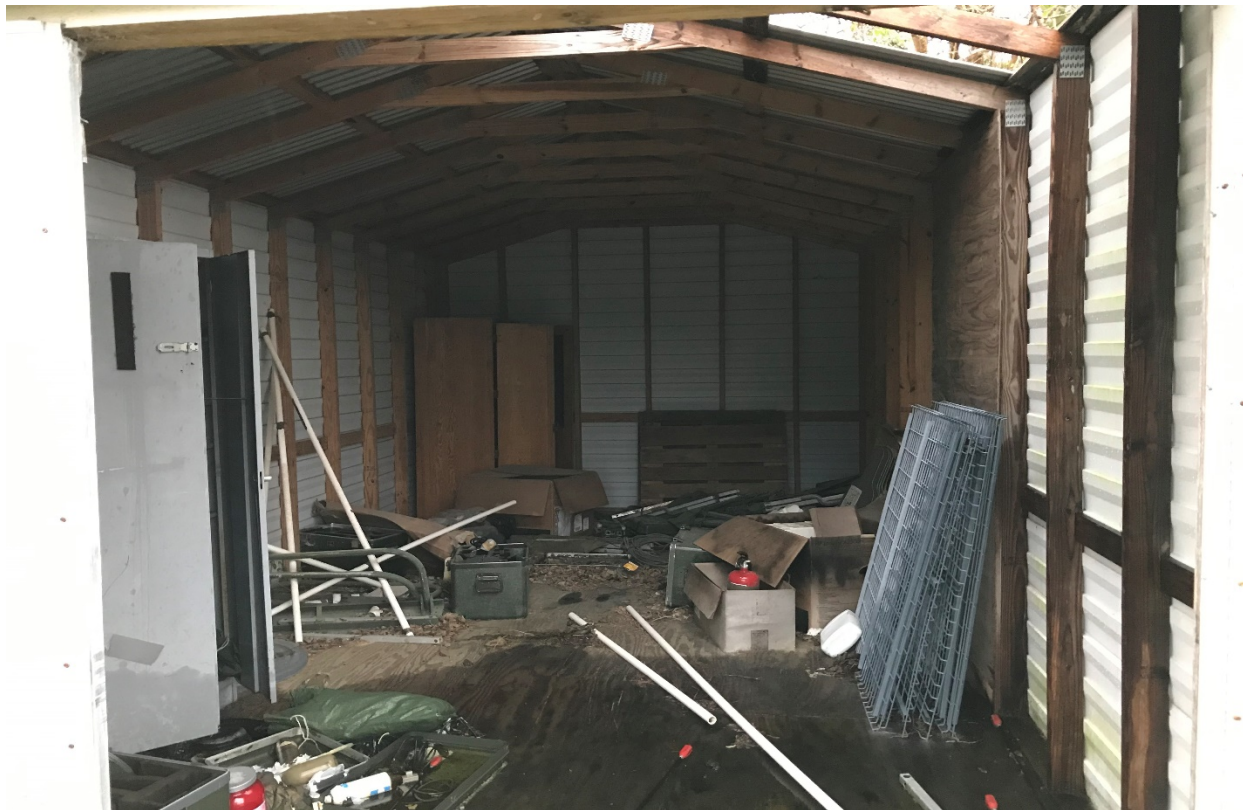
Plate 4: Interior of one of the metal sheds with large damage observed to the exterior.

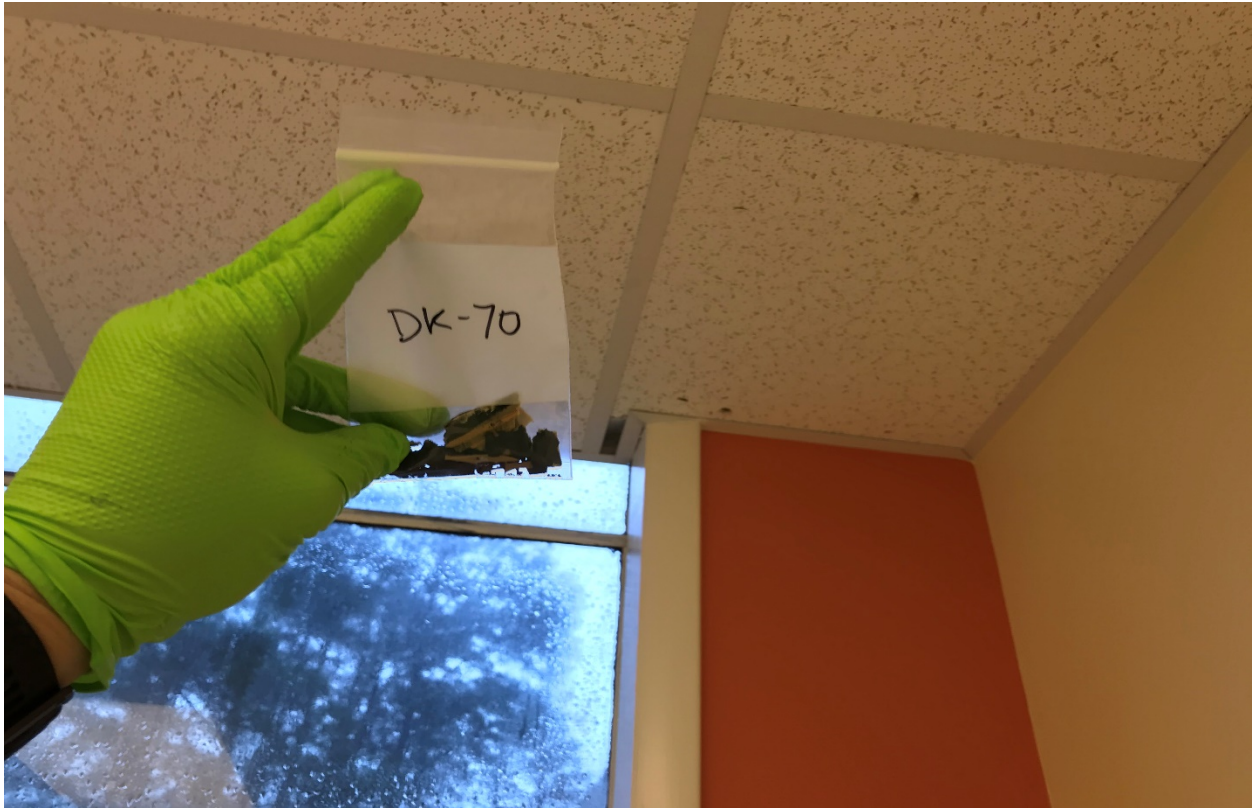
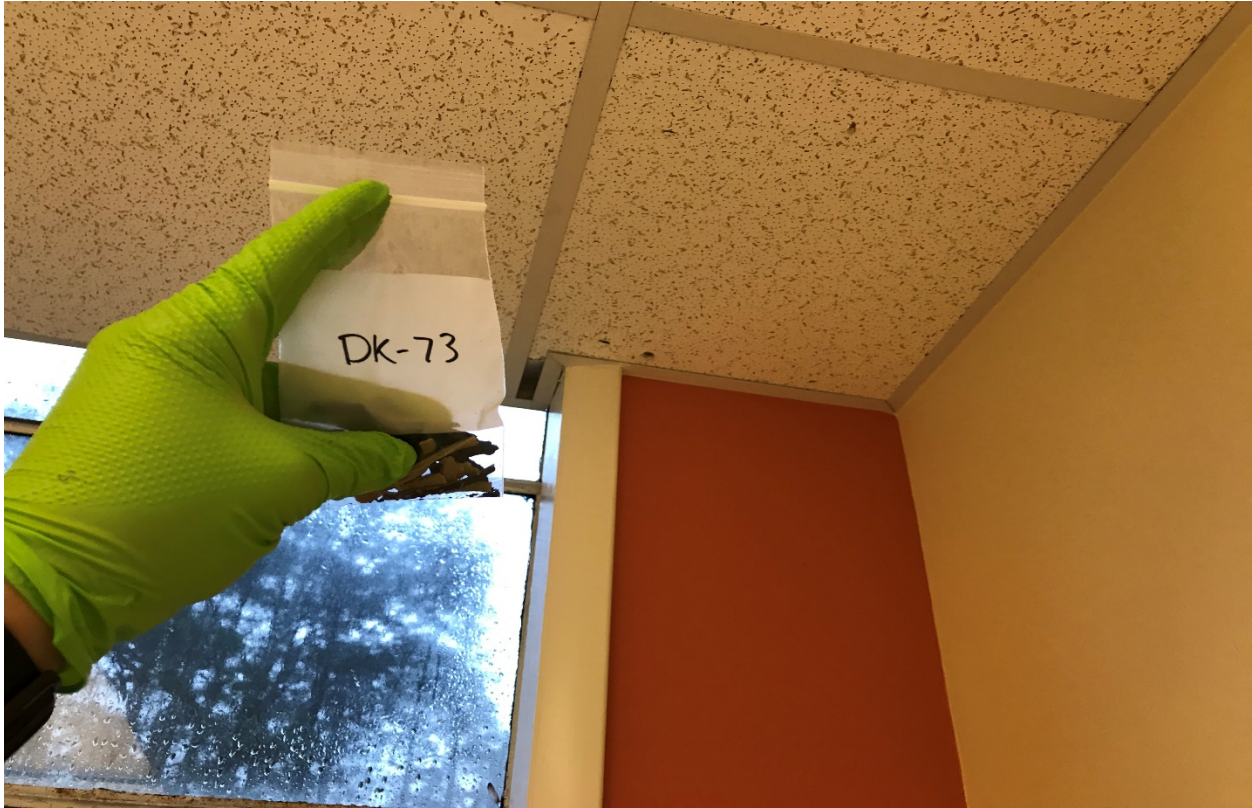
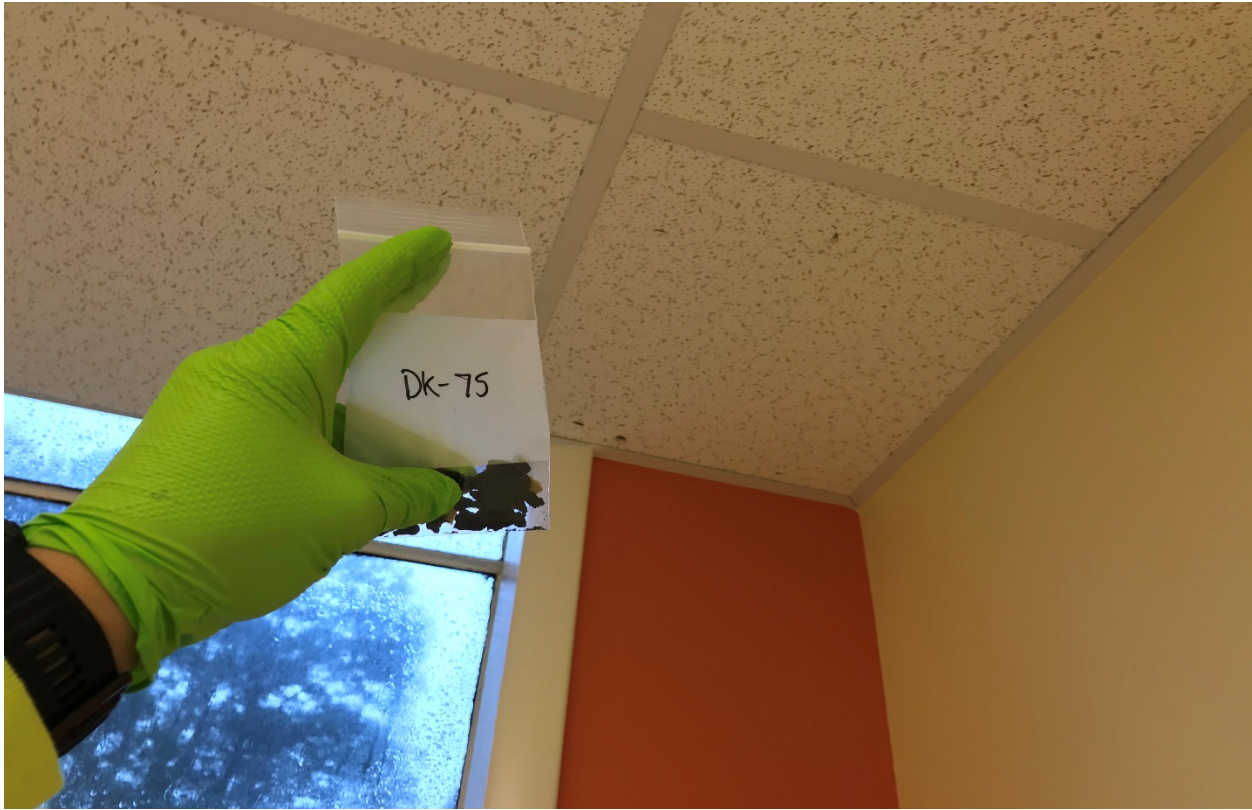
Black Mastic: Laboratory analyses detected 5% chrysotile asbestos minerals within the black mastic on the walls within samples DK-70, DK-73, and DK-75 collected from the large veterinarian patient room (Plates 5 - 8). This black mastic was specifically located above the drop ceiling and behind the drywall. The black mastic is considered a Category II Non-friable ACM as long as it is removed in a manner that does not make it friable. We estimate there to be approximately 600-square feet of black mastic within this room; however, it is possible that more of this mastic is hidden behind other areas of drywall within the building. A photograph of the area from which samples DK-70, DK-73, and DK-75 were collected is shown in Plate 8 in the Appendix.

Plate 5: Laboratory analyses detected 5% chrysotile asbestos minerals within the black mastic of samples DK-70, DK-73, and DK-75 collected from behind the drywall above the drop ceiling of the large veterinarian office patient room.

Plate 6: Laboratory analyses detected 5% chrysotile asbestos minerals within the black mastic of samples DK-70, DK-73, and DK-75 collected from behind the drywall above the drop ceiling of the large veterinarian office patient room.

Plate 7: Laboratory analyses detected 5% chrysotile asbestos minerals within the black mastic of samples DK-70, DK-73, and DK-75 collected from behind the drywall above the drop ceiling of the large veterinarian office patient room.

We recommend the materials listed as ACMs above in the Findings section be considered ACMs in their entirety at the subject property.

Prior to demolition, a licensed asbestos abatement contractor should remove and dispose of the asbestos containing materials identified by this report that will be disturbed during demolition. The Georgia Environmental Protection Division requires notifications for demolition or renovation of ACMs. Additionally, ACMs encompassing at least 10 square feet are regulated by the U.S. Environmental Protection Agency (USEPA) under the National Emissions Standards for Hazardous Air Pollutants and also by the Occupational Safety and Health Administration (OSHA) under its worker protection regulations. These regulations require special handling and disposal procedures when asbestos containing materials are disturbed.

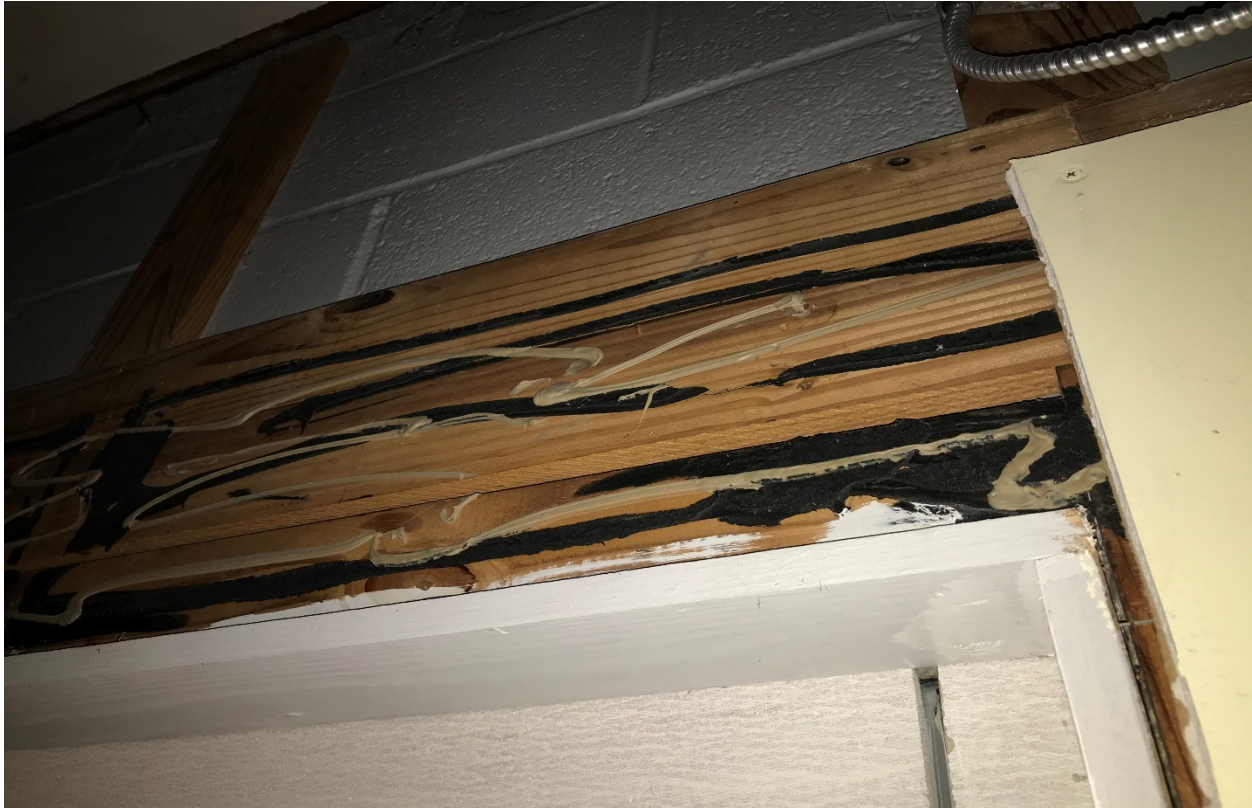
Plate 8: Samples DK-70, DK-73, and DK-75 were collected from behind the drywall above the drop ceiling of the large veterinarian office patient room. The sample locations are represented by the picture above.

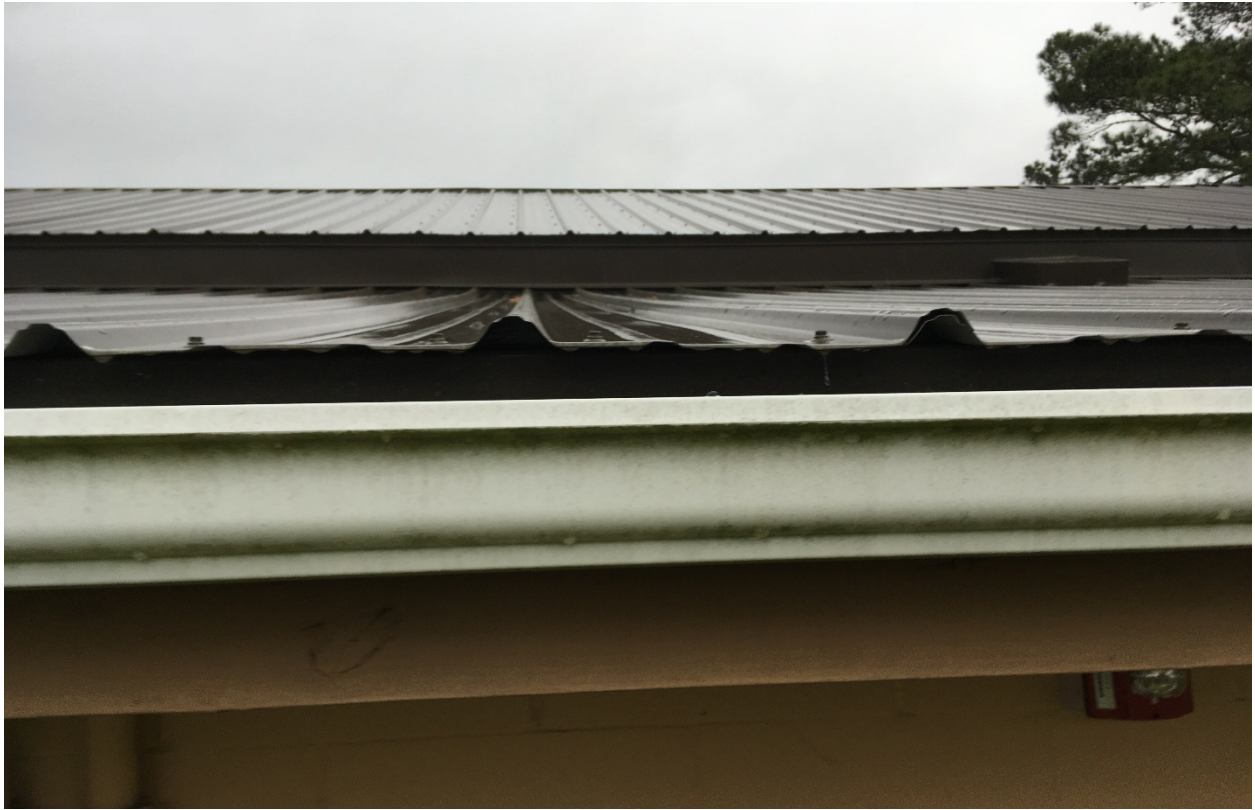
The Military Working Dog Kennel at Hunter Army Airfield building was constructed generally of wood, cinderblock, and metal construction and was finished on the interior with concrete and vinyl flooring materials, wooden paneling, drywall system components, and other materials. The exterior of the building was generally finished with paint and the roof was metal. Nails observed in the sub-roof during our survey of the interior of the Military Working Dog Kennel building indicate that the metal roof of the Military Working Dog Kennel building may have been installed on top of an old roof (Plates 9 and 10). Geo-Hydro attempted to inspect below the metal roof but was unable to remove it. Our personnel did not have roofing tools suitable for sampling and properly patching such a durable roof. Geo-Hydro recommends having the area below the metal roof inspected for suspect ACM before demolition.

Plate 9: During time of site visit the roof appeared to be metal.

The metal roof of the Military Working Dog Kennel building may have been installed on top of an old roof. Geo-Hydro attempted to inspect below the metal roof but was unable to remove it. Our personnel did not have roofing tools suitable for sampling and properly patching such a durable roof. Geo-Hydro recommends having the area below the metal roof inspected for suspect ACM before demolition.

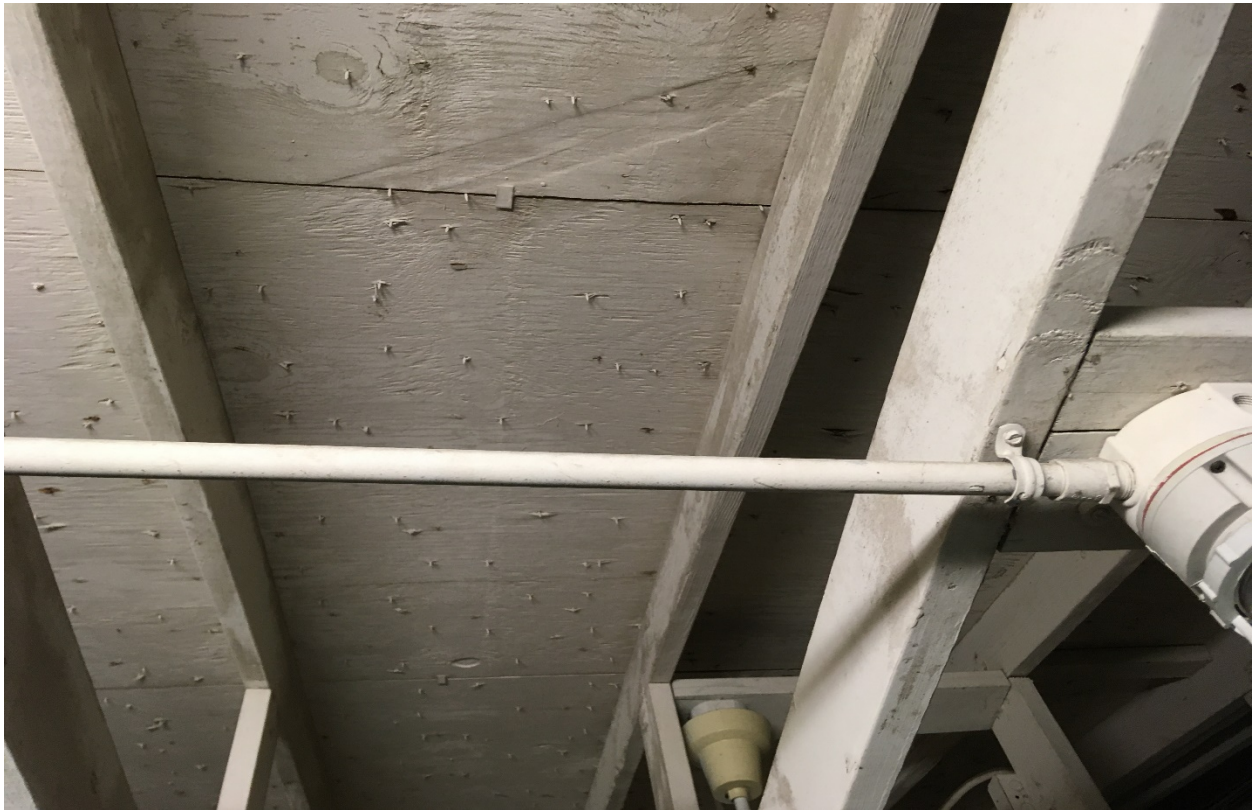
Plate 10: During time of site visit the underside of the roof appeared to have nail penetrations indicative of an asphalt shingle roof.

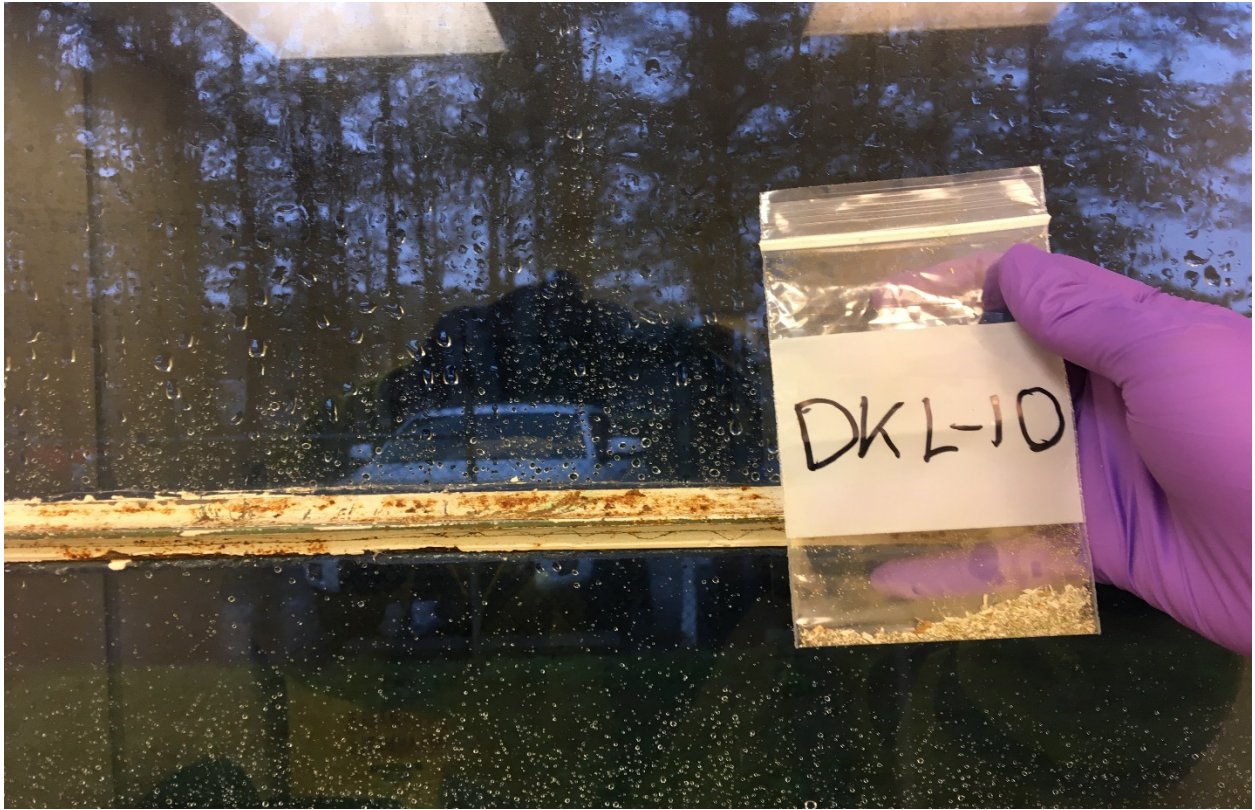
Laboratory analyses detected lead above 0.5% by weight in one of the 11 paint chip samples collected from the subject property. Lead was detected at 0.605% by weight in the white paint within sample DKL-10, collected from an interior metal window (Plate 11). The results of the total lead in paint analyses are presented in the Appendix.

Plate 11: Laboratory analyses detected 0.605% lead by weight in sample DKL-10 collected from the interior metal window in the veterinarian office patient room.

The United States Department of Housing and Urban Development (HUD) defines “lead-based paint” as paint containing more than 0.5% lead by dry weight of the paint. Based on the HUD’s lead-based paint definition, paint chip laboratory analyses did detect lead-based paint associated with one paint chip sample collected during our site visit. We recommend that the demolition contractor make a specific composite sample of the demolition debris for Toxic Characteristic (TC) analysis for lead. Demolition debris from commercial projects consisting of components painted with lead-based paint requires TC analysis for lead. When the demolition debris does not exhibit TC for lead that exceeds the regulatory threshold of 5 milligrams per kilogram as a hazardous waste, then the waste may be disposed in a permitted municipal solid waste landfill or a permitted construction and demolition debris landfill. Materials containing lead-based paint are regulated by the OSHA under its worker protection regulations.
