**Correct FCA Deficiencies in Boiler Plant,
Building 14
at the
Central Alabama Veterans Health Care
System
Montgomery, AL**

**BID DOCUMENTS
Specifications
Volume 3**

Project No.: 619-20-103

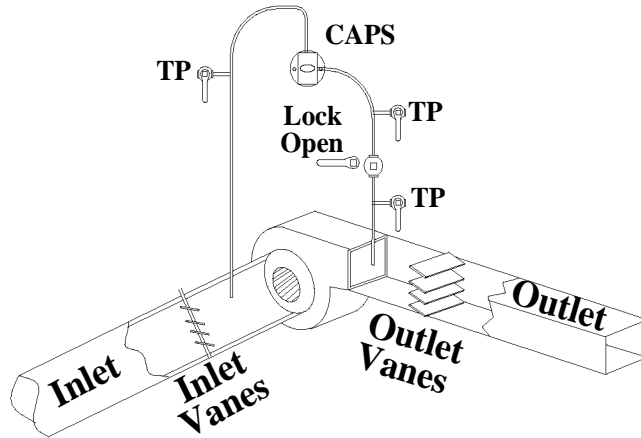
Figure 1.2 Combustion Air Pressure Switch (CAPS) Setup

To test these switches, it is necessary to be able to temporarily isolate these switches from the normal pressure source and either increase or decrease the pressure applied to the switch using the test port to determine the switch trip point. At the same time the piping must be such that the actual pressure that the switch senses can also be measured. The arrangement is pictorially shown in Figures 1.2 for the case of a Combustion Air Pressure Switch. The other switches listed above should be set up in a similar manner as indicated in the respective test procedures in Appendix A.

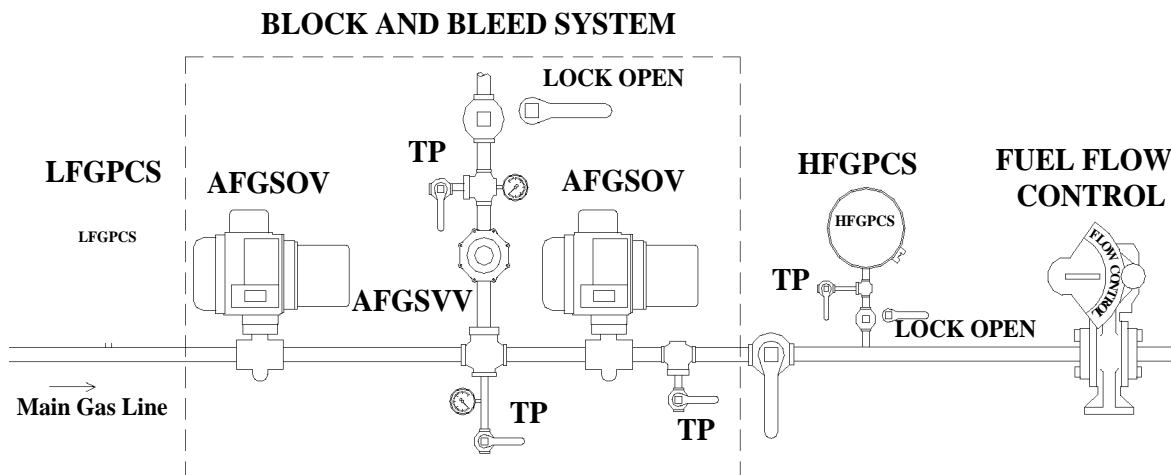
Figure 1.3 Test setup for leak testing the two Automatic Fuel Gas Shut Off Valves and the Automatic Fuel Gas Vent Valve

To easily test for leaks in the block valves, a test port (TP) and calibrated pressure gage must be available both in the line between the valves and downstream of the second valve. Also, in the case of gas, a lockable manual valve downstream of the solenoid bleed vent valve is required. A port and pressure gage in the line between the solenoid valve and lockable manual valve is also needed as shown in Figure 1.3. Note, there are two test ports (TP) for determining normal operating pressures and one test port (TP) for testing the automatic fuel gas vent valve for leaks. This arrangement is schematically shown for natural gas in Figure 1.3. The arrangement for testing the automatic fuel oil valves is the same with the exception the vent line is absent with its attendant test arrangement as shown in the test procedure for oil leaks in Appendix A. (Note that some boiler manufacturers do include a liquid relief valve between the two automatic fuel shut off valves. If this relief valve is included, it must be tested.)

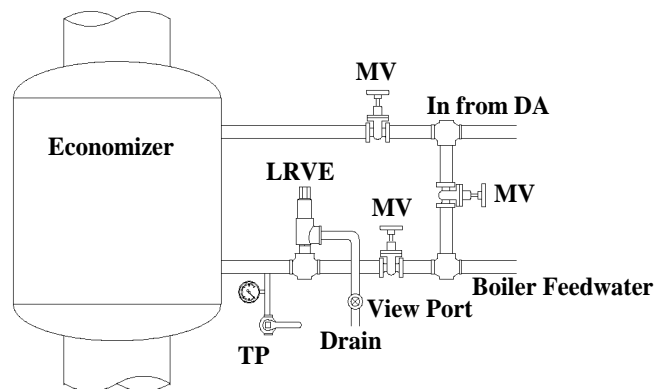
Figure 1.4 Hydro Testing

To hydrostatically test any device, it is necessary that valves are available to isolate the device, a test port is available to apply the test pressure, and a pressure gage is available to monitor the pressure in the device (See Figure 1.4 as an example). All devices that could be damaged by the test pressure must be removed or properly isolated prior to conducting the hydrostatic testing. If it is desired to use a hydrostatic test pressure above the pressure at which the safety valve or liquid relief valve opens, it is necessary to remove the valves and blank off the opening.

To perform a hydrostatic test, fill the vessel completely full of water below 200 F. Remove and/or isolate all safety and relief valves. Close all supply and discharge lines. The boiler must be completely locked and tagged out from all energy sources following OSHA requirements and the fireside opened for inspection. The hydrostatic pressure for the test should be 1.5 times working pressure applied for several hours. The dry side must be checked for any sign of leaks. Any leaks must be professionally evaluated in terms of whether the vessel can be operated safely without repair. In applying the hydrostatic pressure, care must be exercised not to overpressure the vessel. If the vessel were pressurized above its elastic limit, the vessel would not be fit for further use and should be scrapped!

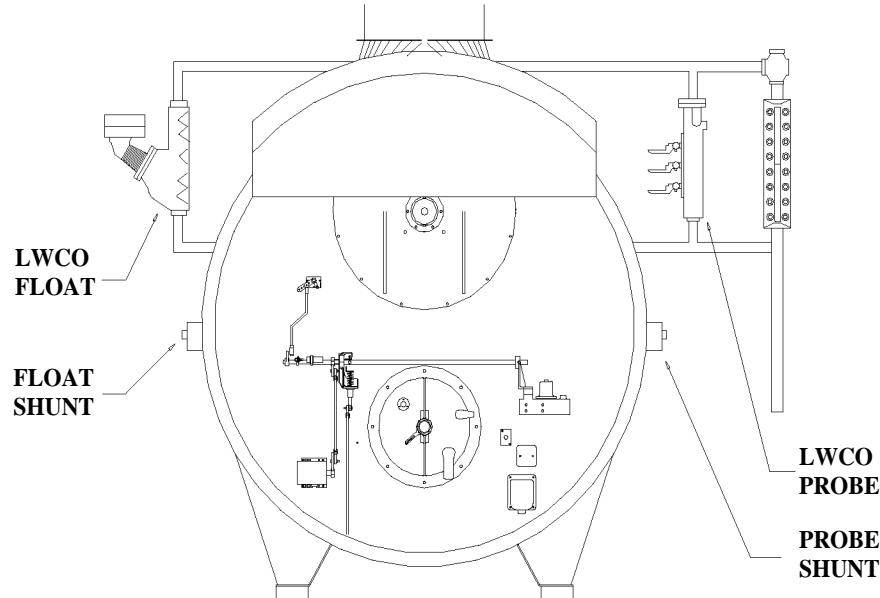
Figure 2.1 Low Water Cutoff

A low water cutoff is a device that causes the automatic fuel safety shutoff valves to close if the water level in the boiler drops below a pre-set safe level. Low water causes about 50 percent of all boiler incidents. Low water can cause the boiler to overheat which could lead to the failure of the pressure vessel with enormous potential damage (explosion). Two low water cutoffs are required for steam boilers while hot water boilers are required to have at least one low water cutoff. Acceptable Low water cutoffs operate either on a "float" system or electrode system (probe) for steam boilers. Any low water cutoff for hot water boilers must be a probe. In the float system there is a pipe connection to the boiler high and low connection points. Between these connection points there is a vertical section containing a volume sufficient to house the float. If the water level falls below a prescribed level, the falling float will cause a switch to actuate causing the automatic fuel valves to close. (See Figure 2.1)

If the low water cutoffs both fail, the boiler would then be fired with no water in the boiler. This will cause the metal temperatures to rise rapidly and the metal strength to be significantly decreased. In fire tube boilers the main Morrison tube typically collapses which could allow steam onto the boiler fireside. The steam pressure has been known to blow the ends out of the boiler through concrete block walls a distance of hundreds of feet. Similar catastrophes could occur in water tube boilers.

Low-water cutoffs must be tested in a mode in which they fail. Testing is basically done by allowing the water level to decrease in a "slow drain". To be in a realistic mode, one must not follow a procedure that actuates the cutoff by rapidly blowing off a volume of water from the water column containing the switch. This is very important in testing a float type cutoff. The rate of decrease in water level is required to be a maximum of 1 inch/minute.

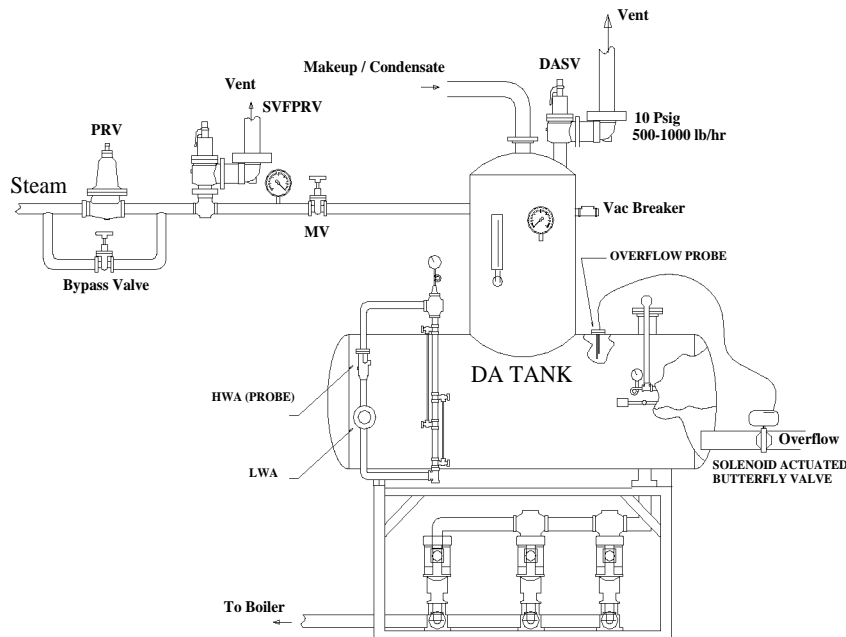
Figure 2.2 Overflow Drain System

Deaerator tanks and condensate storage tanks have overflow systems to prevent overflowing. The deaerator overflow is shown in Figure 2.2. The overflow system on the condensate tank also helps guarantee that the condensate tank remains at atmospheric pressure and consists of a drain line connected to the vessel. The drain line from a deaerator includes a device that opens if the water level is too high and allows water to drain either to sewer or into the condensate tank. The VA requires that the condensate tank be a pressure vessel with the same basic requirements as the deaerator if the deaerator overflows into the condensate tank. The proper device setup is an electronic valve which is operated by a conductivity probe indicating that water level is too high. The signal used to control makeup water into the deaerator must not be used to control the overflow valve.

The consequence of an overflow drain failure is the same as that discussed in section 2.3.2.

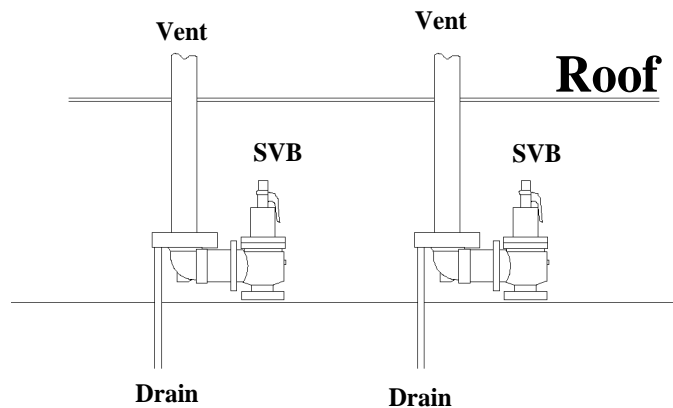
Figure 3.1 Boiler Safety Valves

The steam safety valves are connected to a steam boiler, steam line, or other device that must be protected from over-pressure. Each steam safety valve discharges into a drip pan ell which discharges through a slip joint into an oversized vent pipe that extends to outside the building. By utilizing drip pan ells, there is no direct connection between the vent pipe and the safety valve so that there is no stress imposed on the safety valve from the thermal expansion of the vent pipe. Additionally, any liquid that accumulates due to condensation drains and does not impact relief capacity. Correct installation includes leaving about a one-inch gap between the drip pan and the bottom of the vent pipe. Steam safety valves must be present on a steam boiler, deaerator, any pressurized condensate receiver, and at all points in steam lines just downstream of any pressure-reducing valves. Each safety valve must have a dedicated separate vent line and drain (See Figure 3.1). Properly designed redundant safety systems for this extremely important safety device allow the system to prevent a boiler explosion even if one of the safety valves and/or vent system fails. All steam safety valves must be lifted by steam pressure.

Steam safety valves are the last line of defense against the over-pressurization of a steam boiler or steam system components. If these valves fail along with all the other measures designed to prevent over-pressurization, a violent explosion could occur. Such an explosion could damage buildings and injure or kill people within several hundred feet of the boiler or system component.

Some authorities recommend doing all steam safety valve testing on a test stand. However, there is a chance that the valves could be mixed up or damaged in installation so that this test method is not as reliable as testing the valves in situ and is not allowed by the VA to satisfy compliance. Also, some authorities check a steam safety valve by lifting the handle by hand. This test does not confirm that the valve opens at its proper setting. It does confirm that the valve can vent steam (is not blocked). Lifting of a safety valve by hand does not meet the VA requirement for compliance. Gagging of a safety valve for test purposes is prohibited and should never be used. Steam Safety Valves must be lifted / tested in-situ with steam pressure.

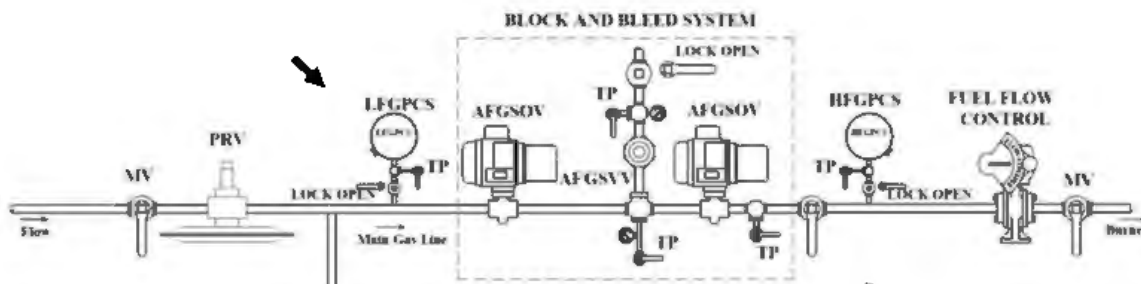
Figure 4.1 Low Pressure Fuel Cutoff

The low-pressure fuel cutoff switch causes the automatic fuel shutoff valves to close if the fuel pressure is below the lower limit for safe operation. Low pressure fuel cutoff switches are found on the main gas line, main oil line, and pilot gas line. The switch in all three of these applications senses the supply fuel pressure after the pressure regulating valve and upstream of any fuel control valve (See Figure 4.1). For the main oil and gas supply lines, the switch is in continuous operation once the boiler is in the run mode. For the pilot gas supply, the switch operates continuously while the pilot flame is on. A common operational problem with a low pressure cutoff switch occurs due to the PRV allowing a "dip" in fuel pressure on startup. Some facilities have installed a snubber or accumulator between the fuel line and switch to prevent the switch from activating. Snubbers and accumulators are not allowed by VA requirements and standards.

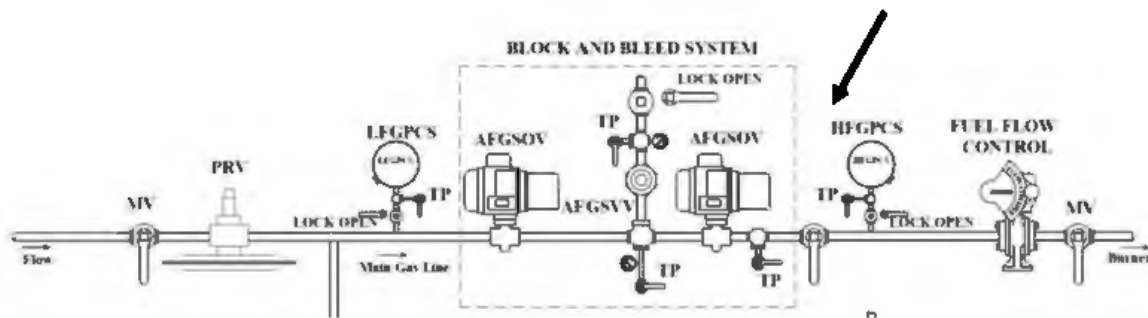
Figure 4.2 High Pressure Fuel Cutoff

The high fuel gas pressure cutoff switch is used to cause the automatic fuel shutoff valves to close if fuel pressure is above a given higher limit for safe operation. These switches are used for both the main gas and main oil fuel supply systems (See Figure 4.2). In both applications the switch should be located after the pressure regulating valve and upstream of the fuel control valve. The switch is in continuous operation once the boiler is in the run mode.

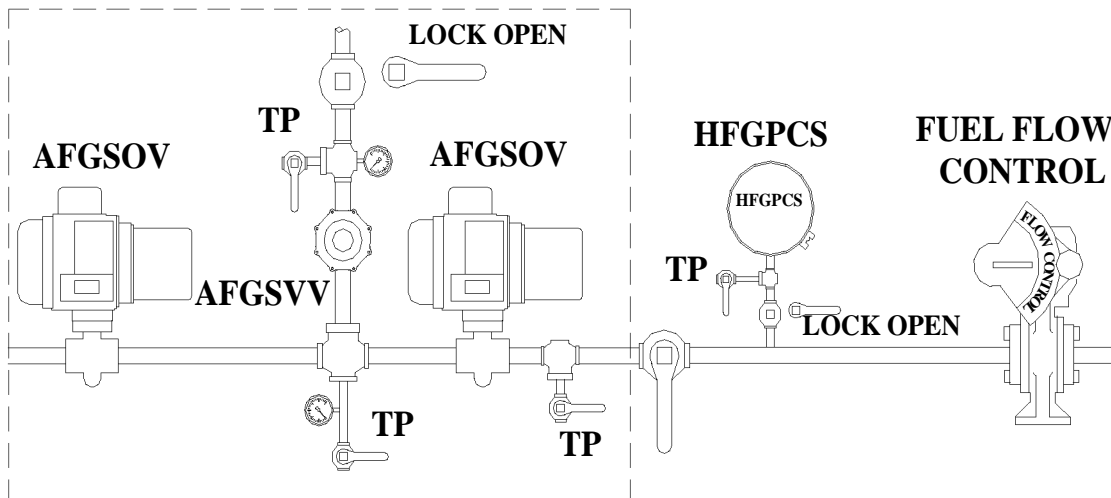
Figure 4.3 Gas Train Vent Valve

BLOCK AND BLEED SYSTEM

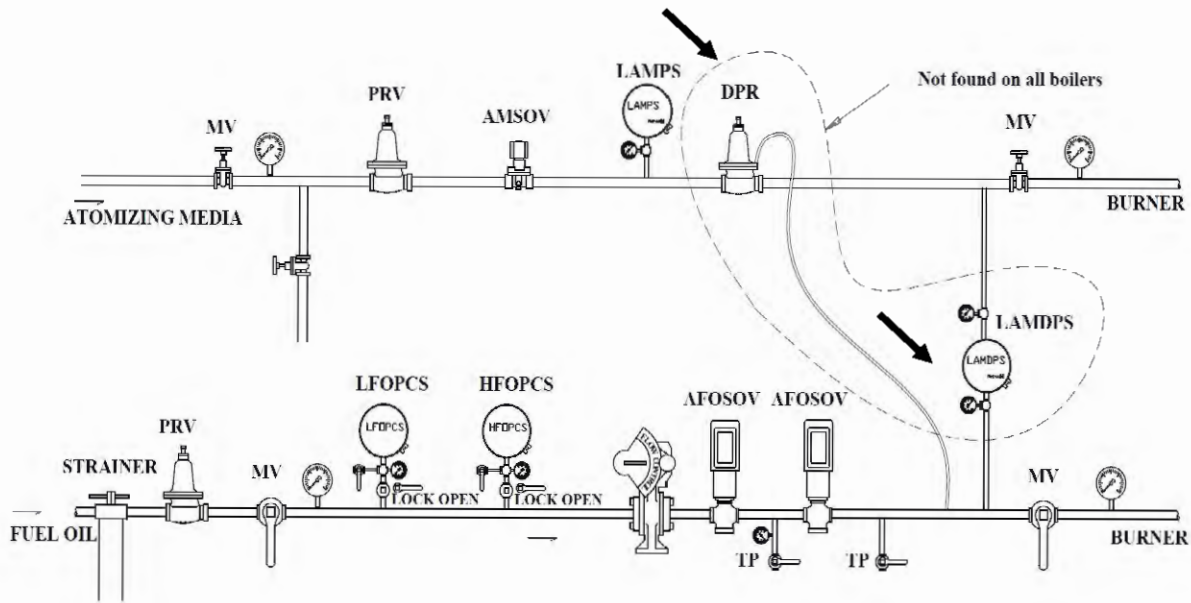
Figure 4.4 Low Atomizing Media and Differential Pressure Switches

In some cases where air is used to atomize, no atomizing media differential pressure regulator is used. For this case the low atomizing media pressure switch described above is needed along with a second switch located near the burner inlet to help ensure that atomizing media is flowing into the burner. For the case in which the atomizing media pressure at the burner is greater than the oil pressure for all firing rates, a differential pressure switch is needed. For the case where the atomizing media is less than oil pressure at some firing rates ("crossover"), a second atomizing proof is required by the VA. The differential pressure switch must be located as shown in the figure. A second atomizing media pressure switch must be in the atomizing media line before it enters the burner.

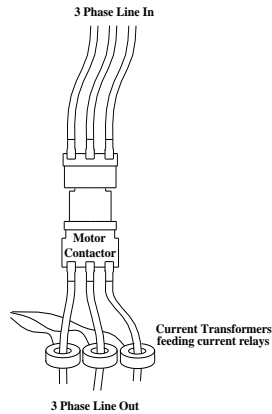
Figure 5.2 Forced Draft Motor Interlock

The forced draft motor interlock provides an extra level of safety relative to proving "purge air flow" and "combustion air flow" and protects the fan motor from running with an inadequate power supply such as single phasing. There are three types of interlocks currently being used. The simplest interlock is an auxiliary contact which is a single pole switch that "makes" when the main switch supplying 3-phase power to the fan is closed. One could cut any or all of the power leads going to the motor and this switch would indicate acceptable operation. For this reason, this interlock is not acceptable. A second design utilizes phase monitors on all three legs that look at the incoming power characteristics that is able to detect a loss of incoming power to the panel. However, the fan motor could be disconnected electrically and the phase monitor would indicate acceptable operation. Again, this interlock is not acceptable. The VA approved interlock is based on current relays in which current in all three legs supplying power to the motor is measured (See Figure 5.2). This interlock involves encircling each power lead with a current pickup. The lack of sufficient current through any of these current pickups will stop boiler operation. For testing, the VA requires the use of a type of current pickup around each lead that can be opened and removed without disconnecting the power lead from its terminal strip. The devices must be set up in a separate electrical enclosure with no exposure to uninsulated high voltage to facilitate safe testing.

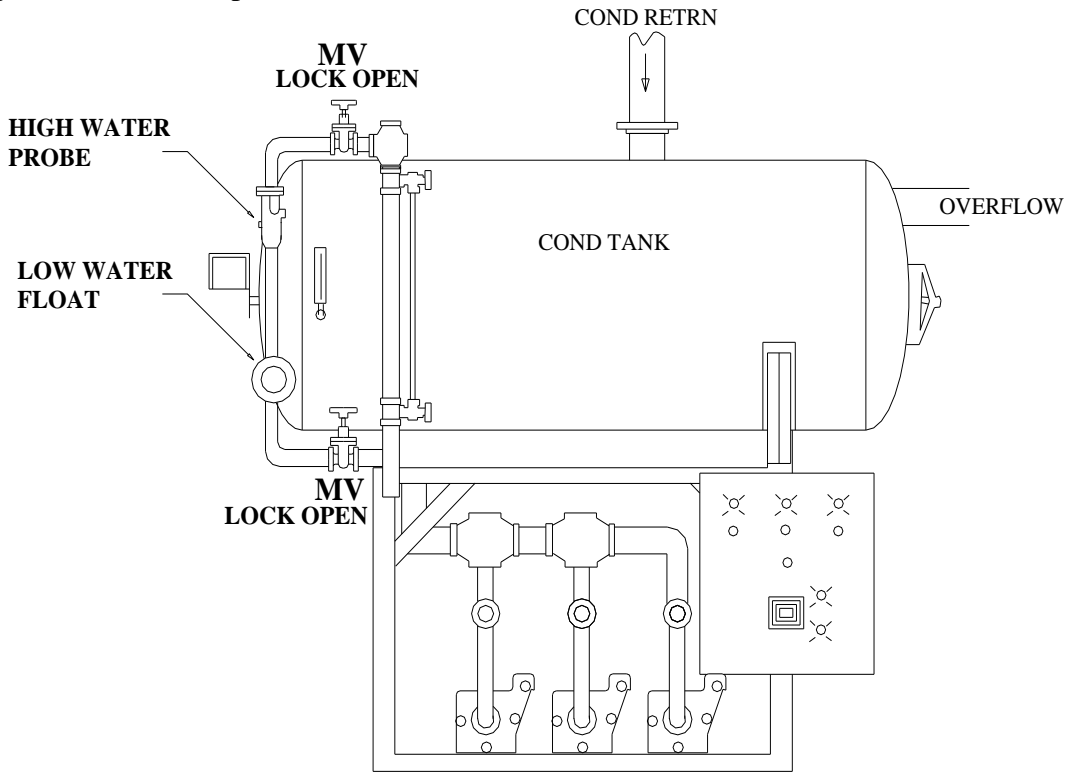
*Alarm set point is required to be at or above 1/3rd of tank height. Device type is required to be a probe or float independent of water level control.

- Verify sight glass in clean and water is clearly visible. Drain sight glass without draining alarm column and then quickly close drain valve. Water level should quickly rise in sight glass indicating good communication with tank.
- If poor communication, clean lines and begin with the step above.
- Drain the water from the condensate tank at a rate not to exceed 1 inch per minute. Use water level sight glass to observe alarm point. **DO NOT ALLOW WATER LEVEL TO LEAVE SIGHT GLASS.** Tank can be either offline or online.

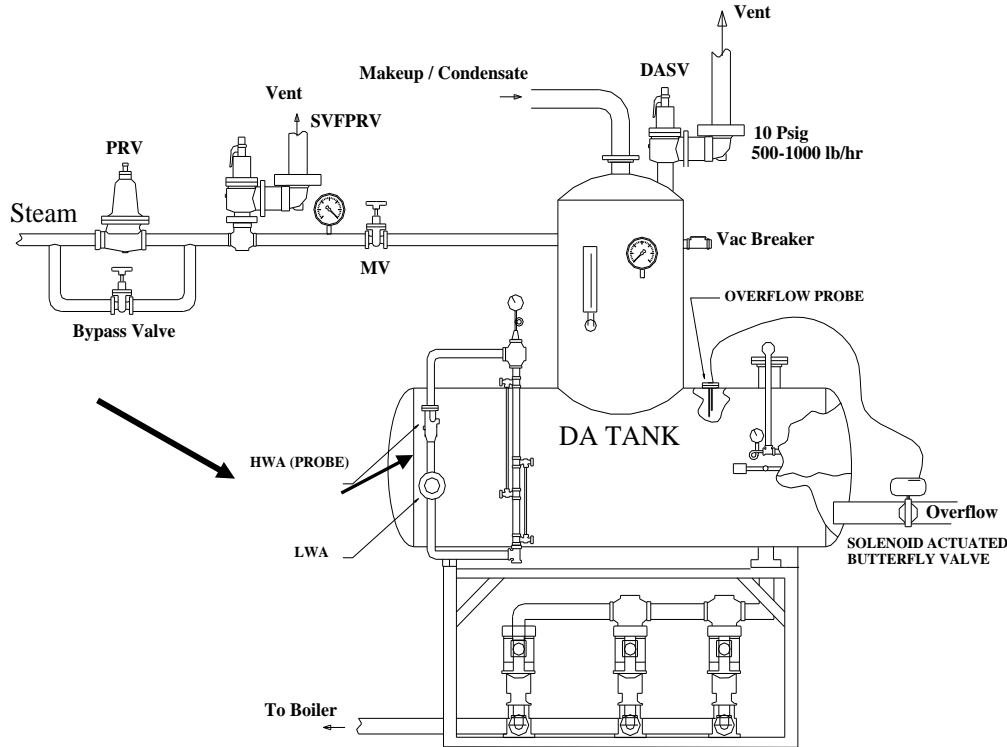
*Alarm set point is required to be at or below 2/3rds of tank height & at least 4” below the level at which the overflow valve actuates. Alarm type is required to be a probe independent of water level control. Tank sight glass must cover full tank height.

- Verify sight glass in clean and water is clearly visible. Drain sight glass without draining alarm column and then quickly close drain valve. Water level should quickly rise in sight glass indicating good communication with tank.
- If poor communication, clean lines and begin with the step above.
- Use makeup or soft water bypass valve to add water to the deaerator at a rate not to exceed 1 inch per minute. Use water level sight glass to observe point that alarm sounds. **DO NOT ALLOW WATER LEVEL TO LEAVE SIGHT GLASS**

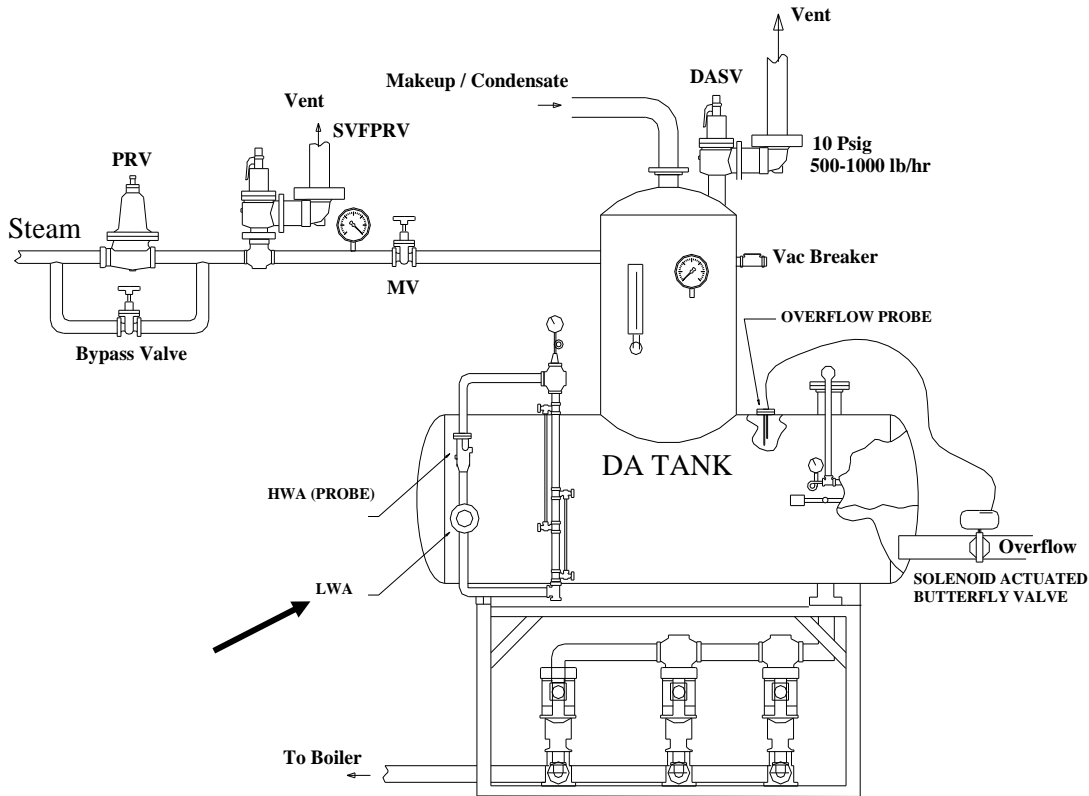
*Alarm set point is required to be at or above 1/3rd of tank height. Device type is required to be a probe or float independent of water level control.

- Verify sight glass is clean and water is clearly visible. Drain sight glass without draining alarm column and then quickly close drain valve. Water level should quickly rise in sight glass indicating good communication with tank.
- If poor communication, clean lines and begin with the step above.
- Drain the water from the deaerator tank at a rate not to exceed 1 inch per minute. Use water level sight glass to observe alarm point. **DO NOT ALLOW WATER LEVEL TO LEAVE SIGHT GLASS.**

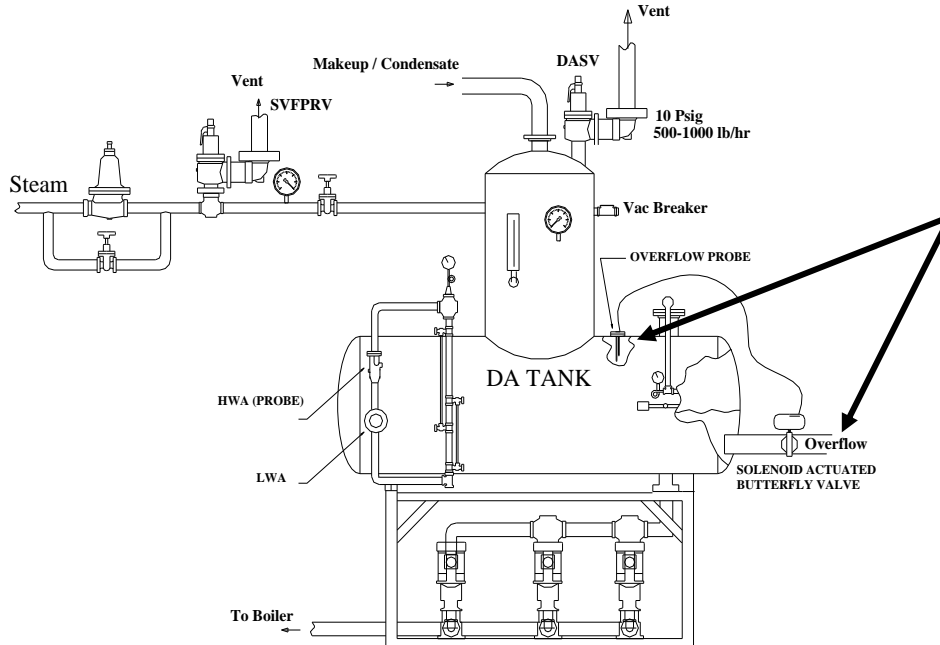
*Overflow system is required to be a conductivity probe connected to an electronic valve that is not used in level control. Setpoint is required to be at least 4” below top of tank. If overflow drains to condensate tank, the condensate tank is required to be properly treated as a pressure vessel.

- Verify sight glass in clean and water is clearly visible. Drain the sight glass and quickly close drain valve. Water level should quickly rise in sight glass indicating good communication with tank.
- Open manual bypass valve to supply feedwater at maximum rate.
- Determine that overflow valve has opened by using sight glass in drain line or visually observing drain. Use water level in sight glass on tank to observe whether overflow valve maintains water level visible in sight glass. **DO NOT ALLOW WATER LEVEL TO LEAVE SIGHT GLASS.**

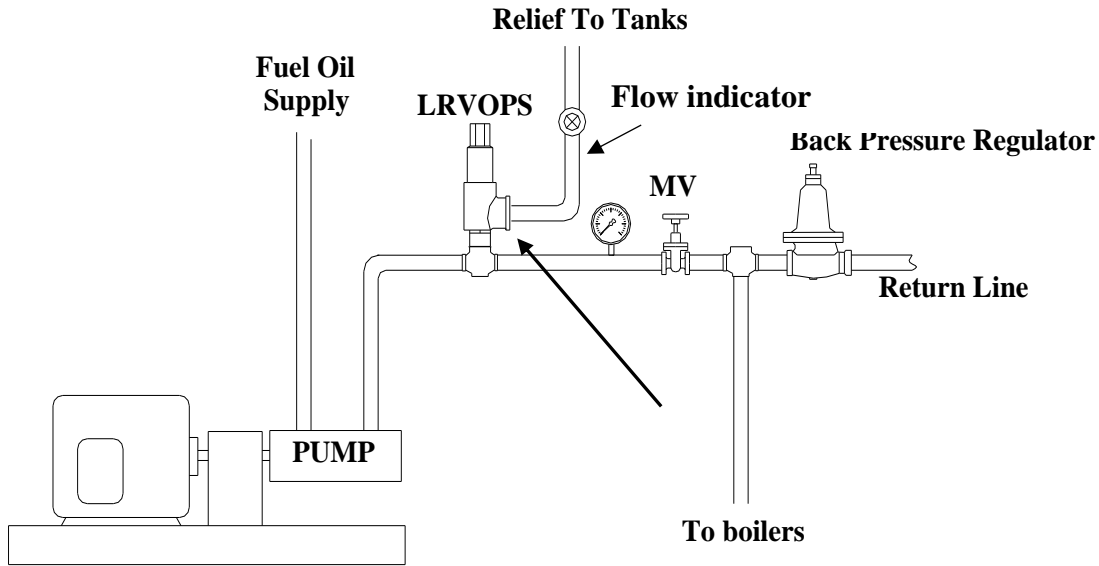
* LRVOPS is required not to be used as a backpressure regulator.

- Slowly close manual valve in oil line after relief valve or raise pressure regulator set pressure until relief valve lifts (use view port to determine if valve is open).
- The pressure should rise no more than 10 psig above normal regulated oil supply pressure.

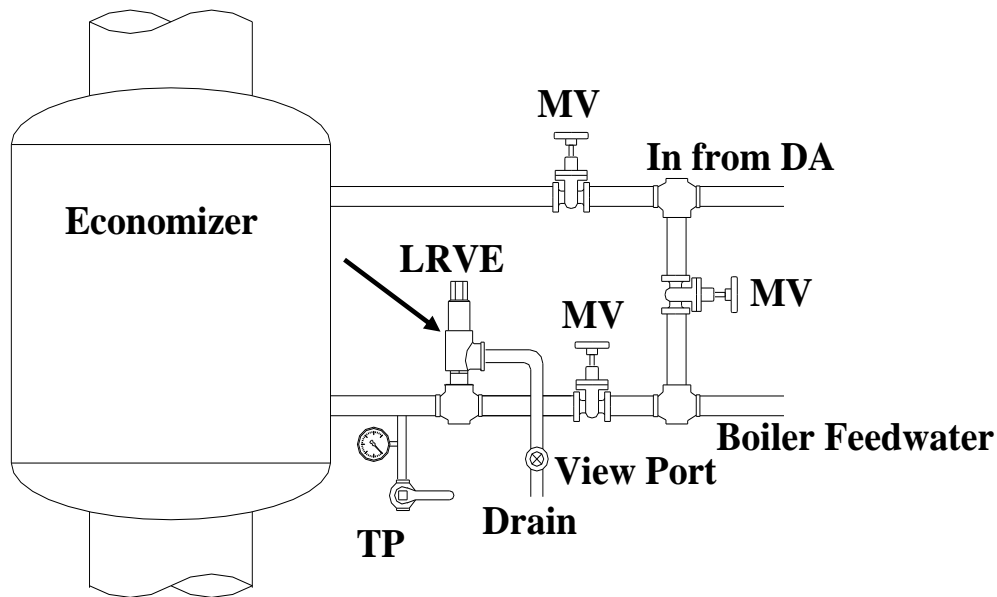
- With boiler offline use manual valves shown in above figure to isolate economizer and relief valve. Use hydrostatic test pump to raise pressure and open relief valve (use view port to determine when valve is open). **DO NOT RAISE PRESSURE MORE THAN ALLOWABLE ECONOMIZER PRESSURE!!!**

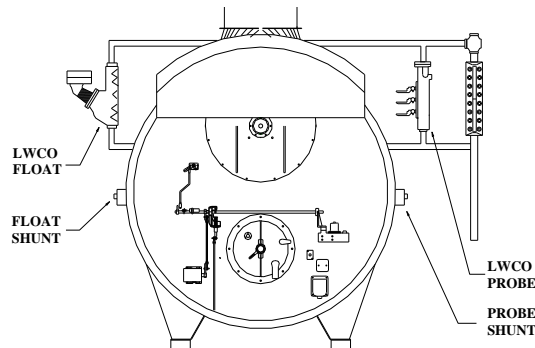
*An Independent shunt (bypass) switch is required to be installed for each LWCO. The VA requires one float and one probe low water cutoff. No automatic re-start after a low water cut out is allowed by the VA. Visible separation of water level in sight glass between all alarms is required. Water level in sight glass is required to be visible for all alarms and cutouts.

- IN PERFORMING TEST NEVER LET WATER LEVEL LEAVE SIGHT GLASS!!!
- Drain sight glass without draining alarm column. Quickly close drain valve. Water level should quickly rise in sight glass indicating good communication with boiler.
- If poor communication, clean lines and begin with the step above.
- With boiler in manual at low fire, close the feedwater valve to generate a slow drain. You may “crack” the blowdown valve but do not exceed a drain rate of 1 inch per minute. Use water level in sight glass to observe alarm point. The alarm should sound first.
- Continue to drain until the low water cutoff activates.
- Verify that each shunt device **ONLY** isolates its respective LWCO.
- Shunt (use bypass switch) the low water cutoff, restart the boiler, and set up drain as described above until the auxiliary low water cutoff activates. Record water level.

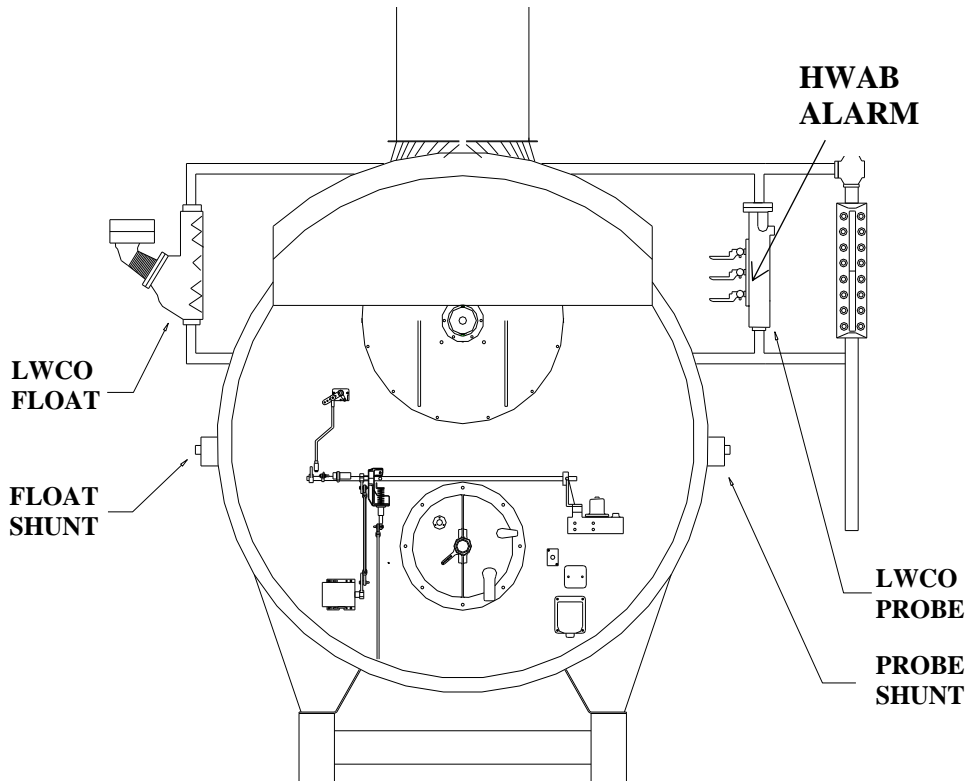
*High water alarm must activate with burner switch in the OFF position. Sight glass water level is required to be 1” or more below top of sight glass at alarm. Alarm device is required to be a probe type device independent of water level control.

- Drain sight glass without draining alarm column and quickly close drain valve. Water level should quickly rise in sight glass indicating good communication with boiler.
- If poor communication, clean lines and begin with the step above.
- With boiler off, open the bypass feedwater valve to fill the boiler. Use water level in sight glass to observe alarm point. The alarm should sound before water level leaves sight glass. **DO NOT ALLOW WATER LEVEL TO LEAVE SIGHT GLASS.**
- Close the bypass on feedwater line

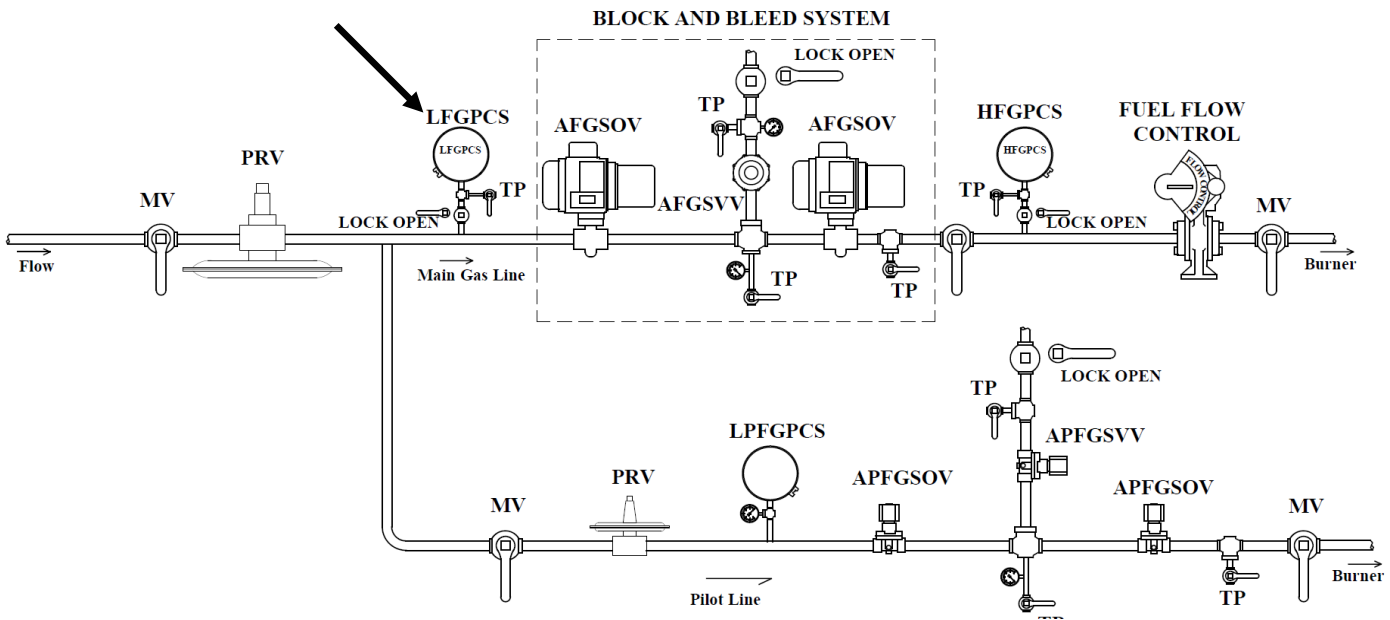
*LFGPCS is required to be downstream of PRV and upstream of AFGSOV with a setpoint of 80% or higher than regulated pressure. The use of snubbers or dampeners on LFGPCS is prohibited. LFGPCS activation must generate a boiler safety shutdown, annunciate, and require manual reset of the flame safeguard or burner management system.

- Connect a line containing a test pressure gage followed by a manual needle or globe bleed valve to the test port. The manual valve should be closed.
- Open test port valve.
- With boiler in low fire, close lockable manual valve isolating the LFGPCS.
- Slowly open manual bleed valve to reduce pressure until boiler trips offline.

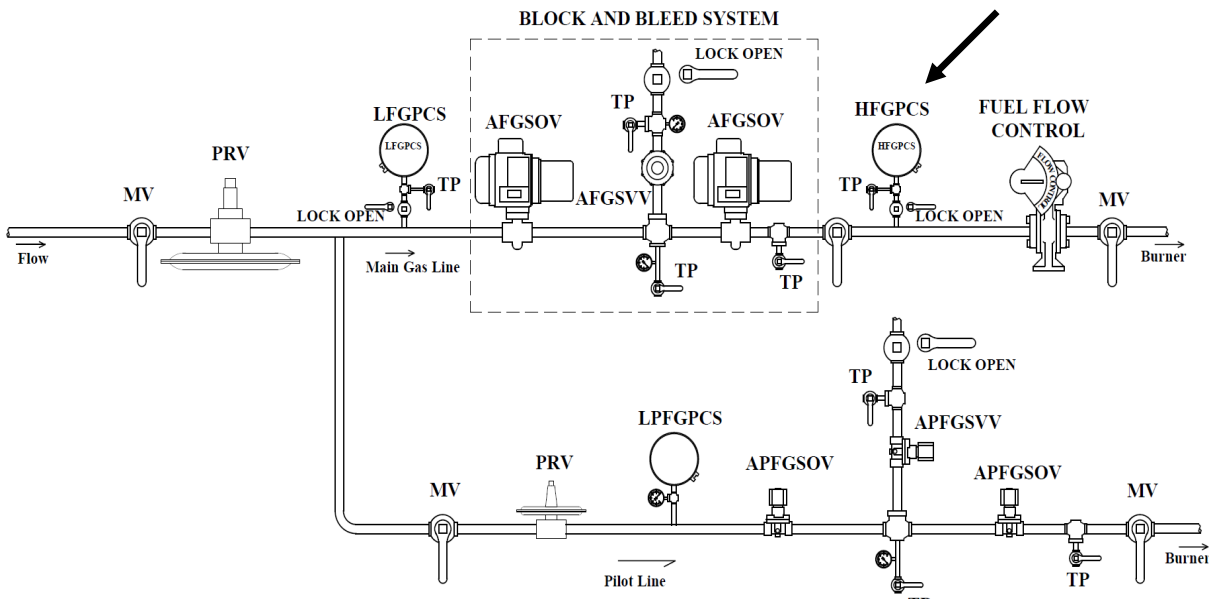
- Connect a line containing a test pressure gage and pump setup to the test port.
- Open test port valve and manual valve in the line connected to test port.
- With boiler in low fire close lockable manual valve isolating the HFGPCS.
- Use a hand air pump to slowly raise the pressure on the HFGPCS but NO HIGHER THAN 120% OF REGULATED PRESSURE.

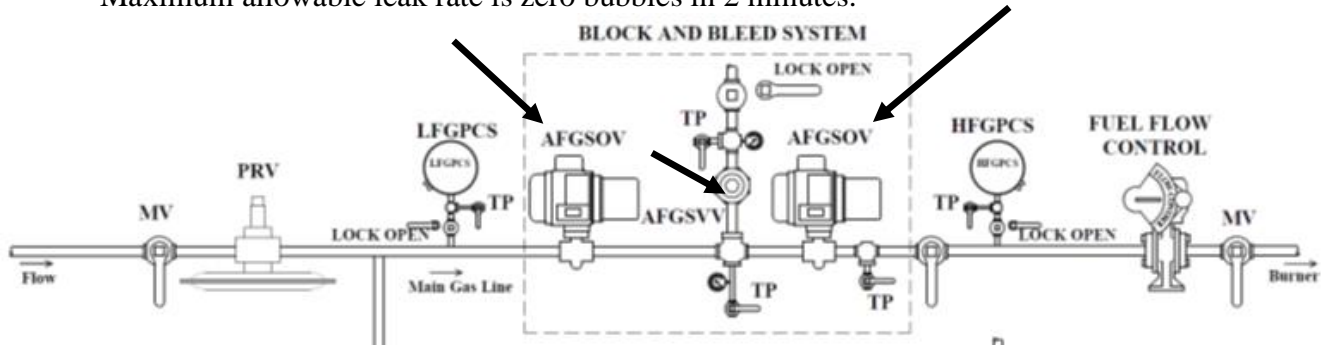
Vent Valve Leak Test

*Maximum allowable leak rate is zero bubbles in 2 minutes.

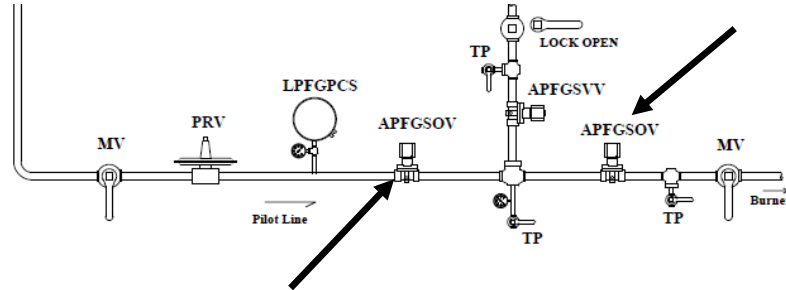
Vent Valve Leak Test

*Maximum allowable leak rate is zero bubbles in 2 minutes.
